# Inventory & Schedule of Condition

Test house  
Any Town  
Wiltshire

**July**  
**1st 2026**

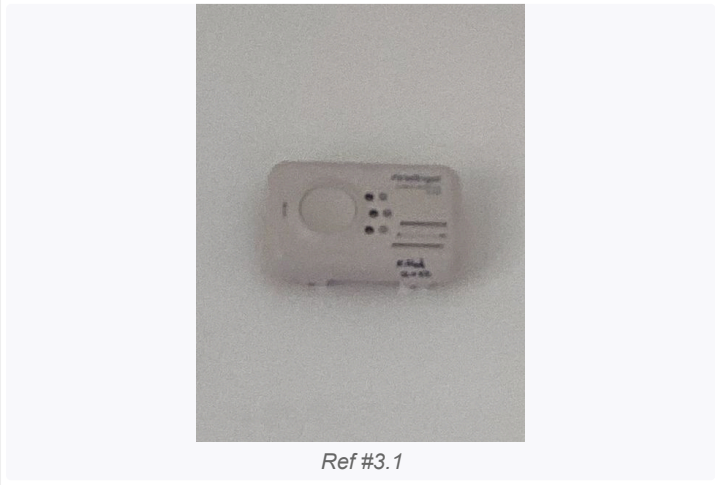
| Ref | Name | Answer | Comments |
|---|---|---|---|
| 3.1 | Alarm tested for power only. Audible alarm heard? | No | White carbon monoxide alarm installed on ceiling in kitchen<br>Needs Maintenance |

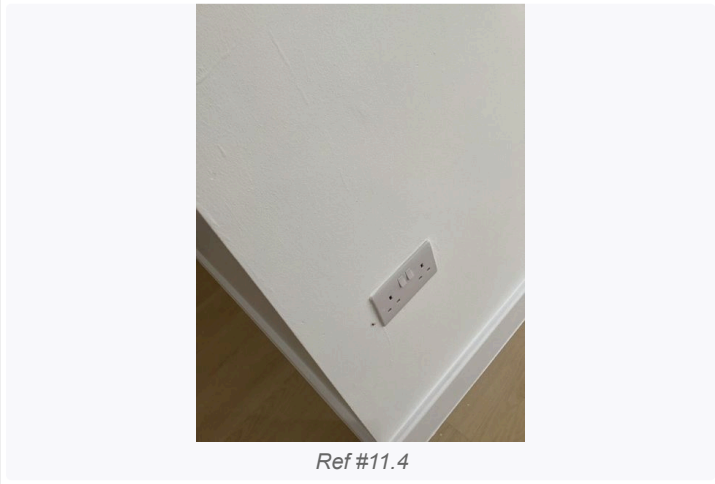
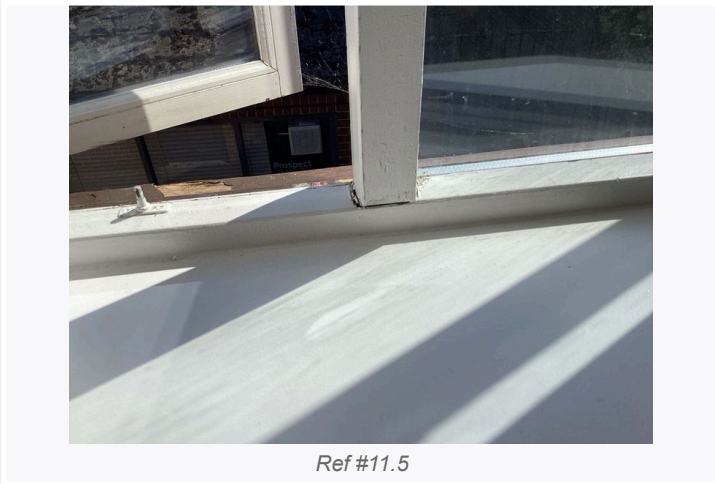
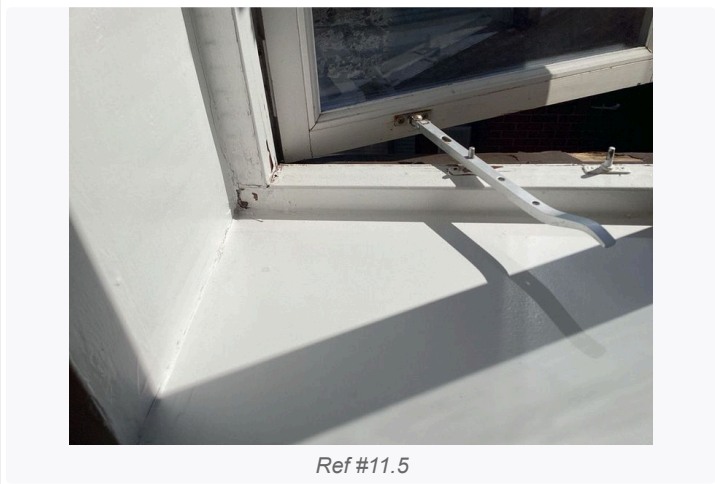
Ref #11.4

| Ref | Name | Description | Condition |
|---|---|---|---|
| 11.4 | Walls | Painted plastered walls in an off-white shade with multiple plug sockets and skirting board present. | Walls show minor surface imperfections and unevenness, overall intact with no visible cracks or severe damage. |

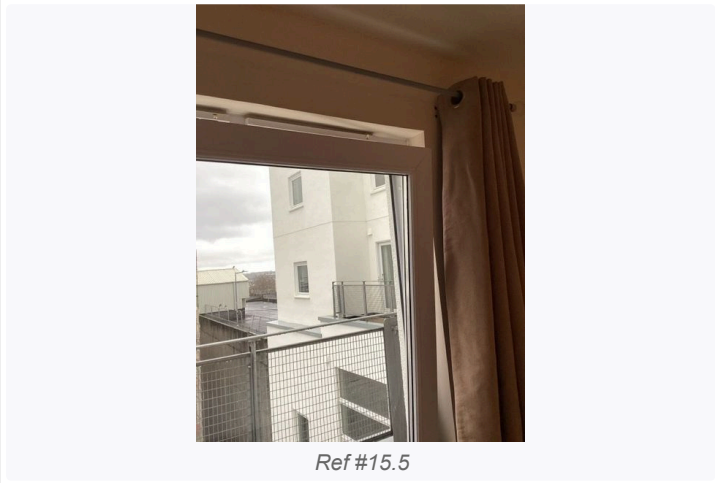
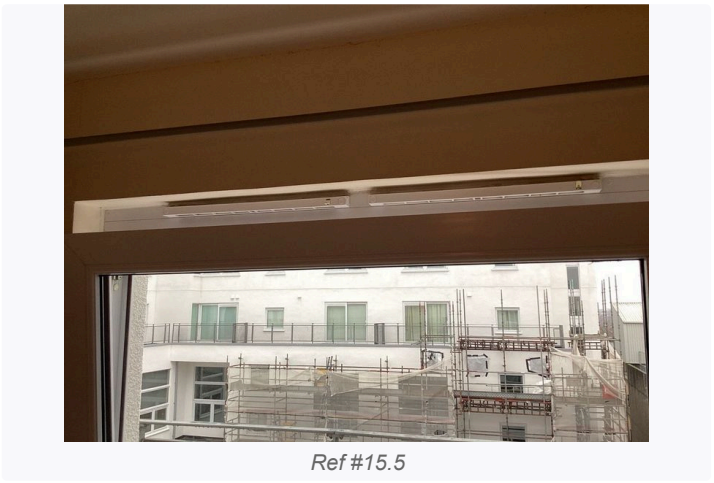
Ref #15.5

| 15. BEDROOM 2 (CONT.) | | | |
|---|---|---|---|
| 15.5 | Window | White uPVC double glazed tilt and turn window with integrated handle and trickle vent. | Window frame and glass in good condition with no visible cracks; window sill has visible cracks and some scuff marks. |
