# Inventory & Schedule of Condition

Test house  
Any Town  
Wiltshire

**July**  
**1st 2026**

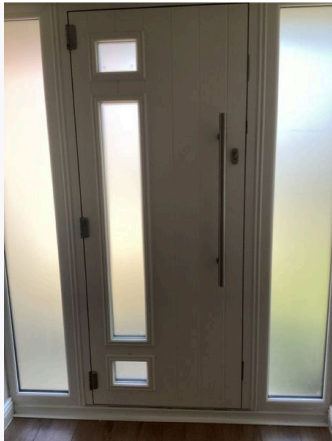
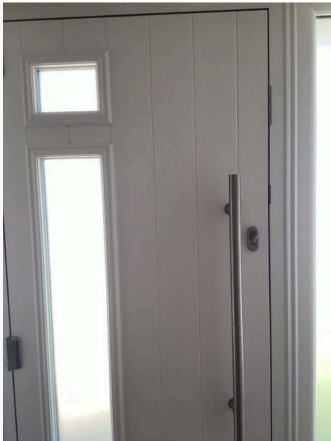
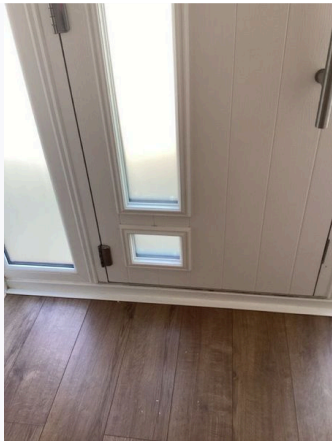
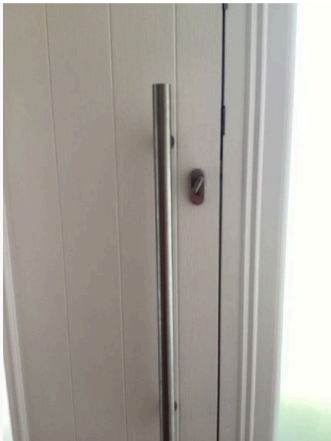
| 9. ENTRANCE / HALLWAY | | | |
|---|---|---|---|
| 9.1 | Door | White composite front door with vertical panel detailing, three rectangular glazed inserts, long brushed metal handle, and frosted side panels. | Door surface and glazing are in clean condition with no visible damage, minor scuffing present on the lower edge of the frame. |

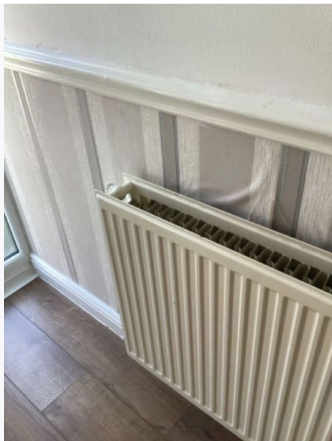
Ref #9.4

| 9. ENTRANCE / HALLWAY | | | |
|---|---|---|---|
| 9.4 | Walls | Walls are painted cream above dado rail and finished with vertical grey and white striped wallpaper below, with white woodwork trim and skirting. | Minor marks and scuffs, some screw holes visible, otherwise intact with no significant damage observed. |

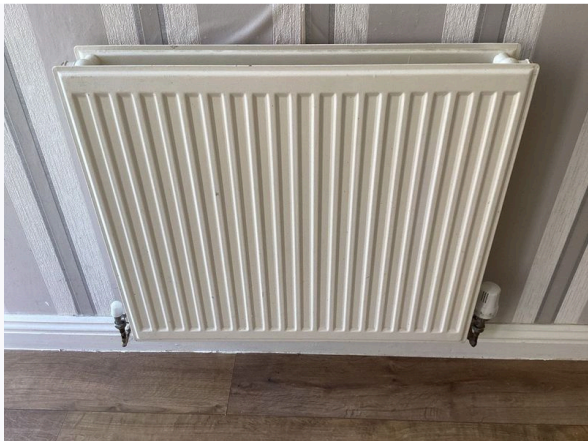
Ref #9.5

| 9. ENTRANCE / HALLWAY | | | |
|---|---|---|---|
| 9.5 | Heating | White metal panel radiator with vertical ridges and thermostatic valve located on the right side. | Radiator casing has minor marks and the valves show some tarnishing but no visible damage. |

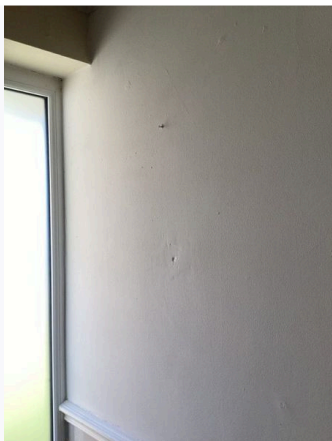
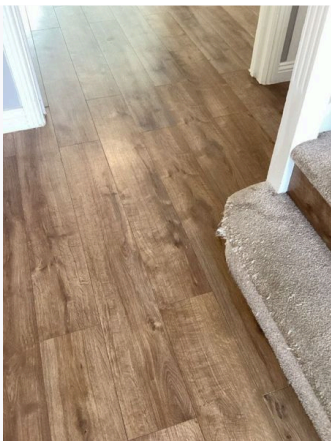
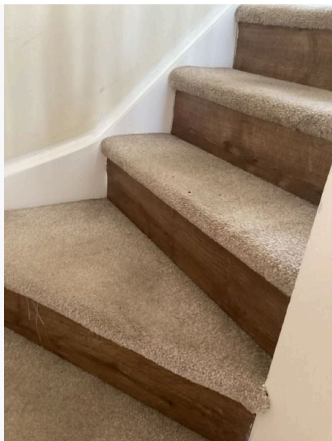
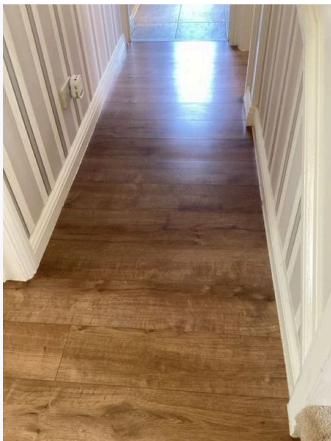
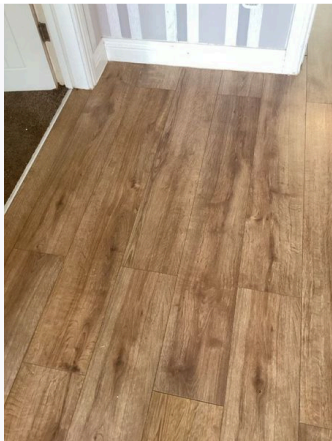
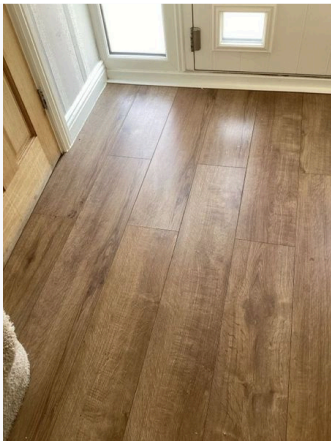
| 9. ENTRANCE / HALLWAY | | | |
|---|---|---|---|
| 9.6 | Flooring | Wood-effect laminate flooring in a medium oak finish extends throughout the entrance and hallway area with carpeted stairs in a light beige colour. | Laminate flooring is in good condition with no visible damage while the edge of the stair carpet is fraying and slightly worn. |

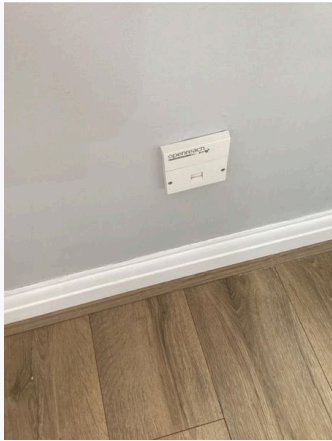
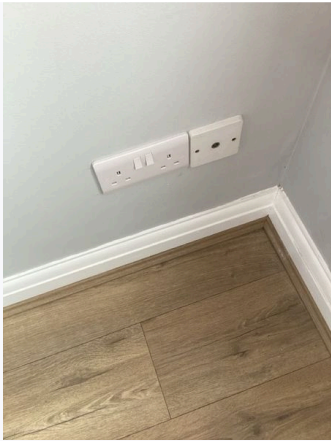
Ref #9.7

| 9. ENTRANCE / HALLWAY | | | |
|---|---|---|---|
| 9.7 | Woodwork | White painted skirting boards with a smooth finish running along the base of neutral coloured walls above light wood laminate flooring. | Skirting boards are intact with no visible damage or marks and paintwork appears even throughout. |

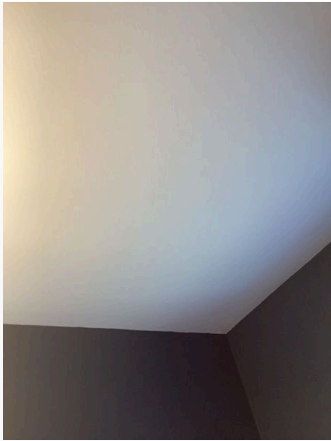
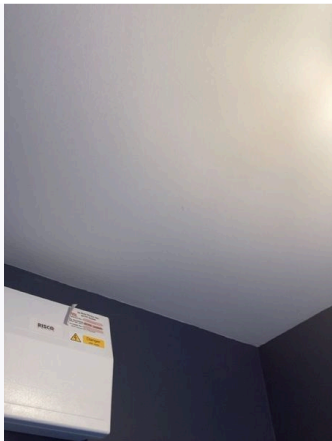
Ref #10.2

| Ref | Name | Description | Condition |
|---|---|---|---|
| 10.2 | Ceiling | Smooth white painted plasterboard ceiling with no visible fixtures | Ceiling is intact with no signs of damage, stains or cracks visible |

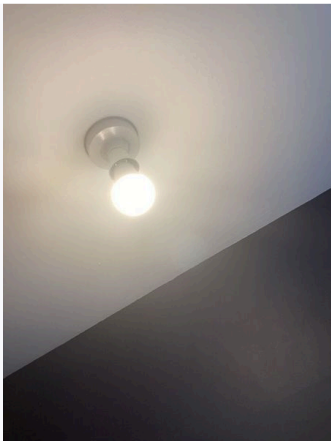
Ref #10.3

| Ref | Name | Description | Condition |
|---|---|---|---|
| 10.3 | Lighting | Ceiling-mounted light fitting with a white plastic holder and exposed white bulb. | Lighting is operational with no visible damage or significant wear. |

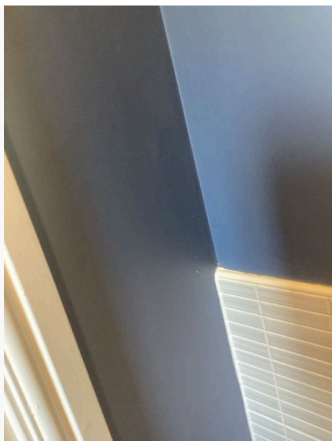
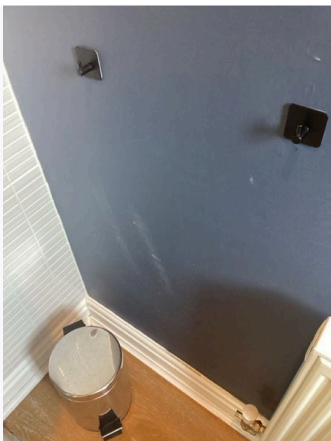
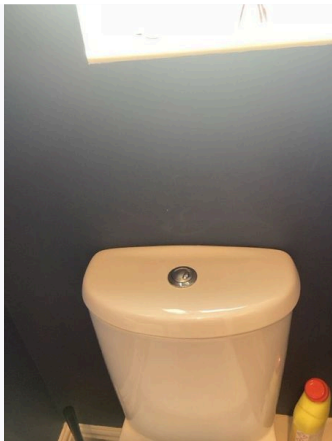
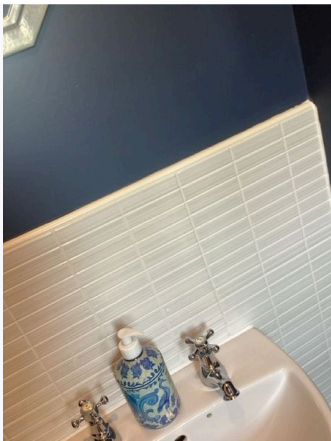
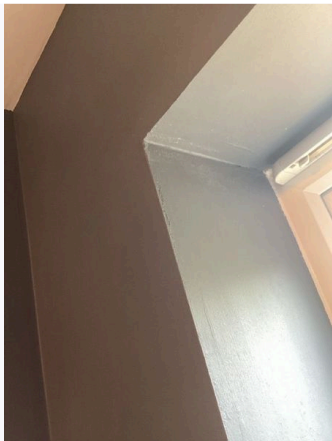
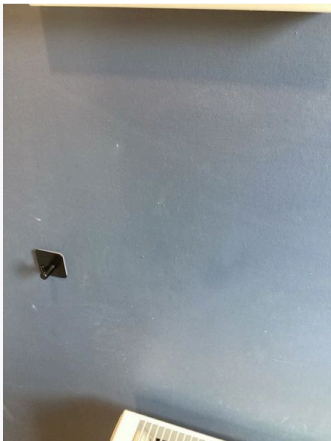
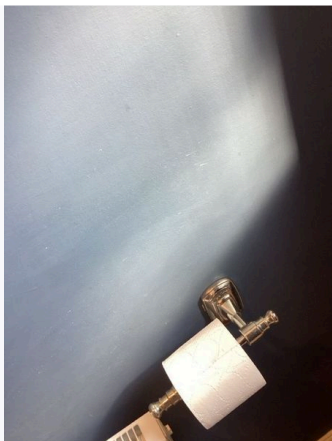
Ref #10.4

| 10. TOILET (CONT.) | | | |
|---|---|---|---|
| 10.4 | Walls | Painted plaster walls in a matte dark blue finish with part-tiled areas in white rectangular ceramic tiles above the sink and behind fixtures. | Walls show signs of light marking and scuffing in several areas with no obvious significant damage or cracks, tiles appear intact with no visible chips or missing grout. |

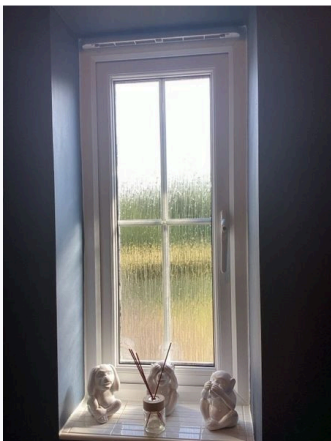
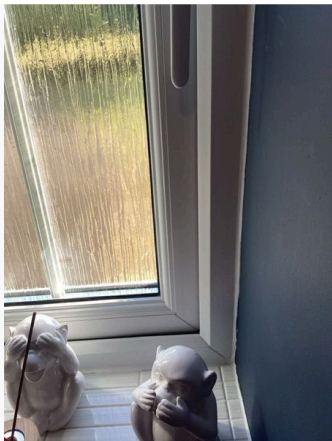
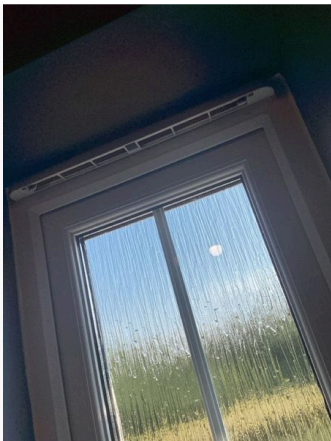
Ref #10.5

| 10. TOILET (CONT.) | | | |
|---|---|---|---|
| 10.5 | Window | White uPVC double-glazed window with obscure patterned glass and vertical central handle. | Window frame, handle, and glass appear in good condition with no visible signs of damage or wear. |

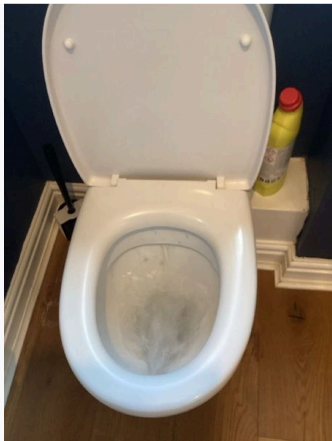
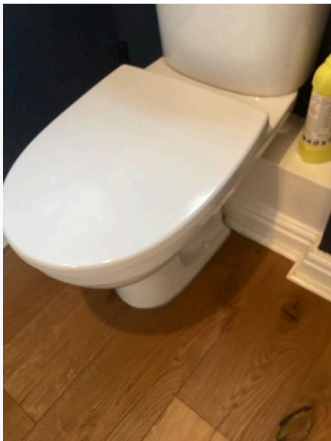
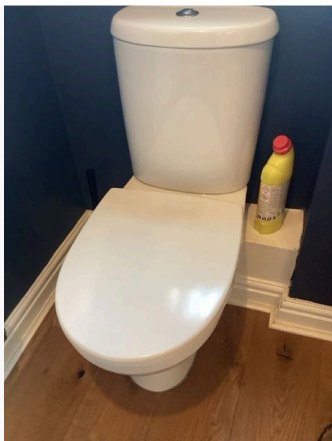
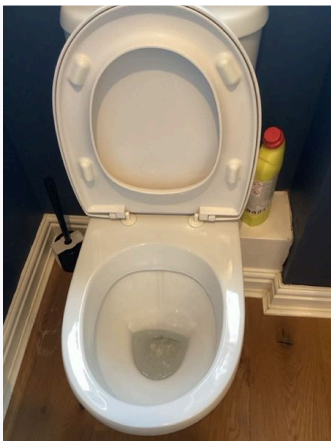
Ref #10.6

| 10. TOILET (CONT.) | | | |
|---|---|---|---|
| 10.6 | Toilet | Close-coupled white ceramic toilet with matching seat and lid, dual flush button and standard pan design. | No visible chips or cracks, minor staining inside the bowl, exterior surface and seat appear intact and clean. |

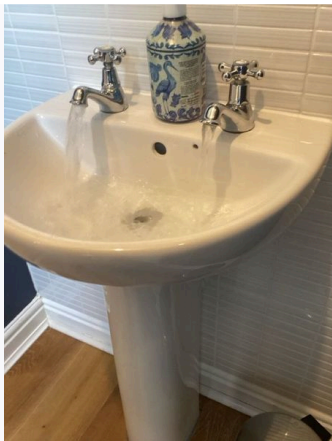
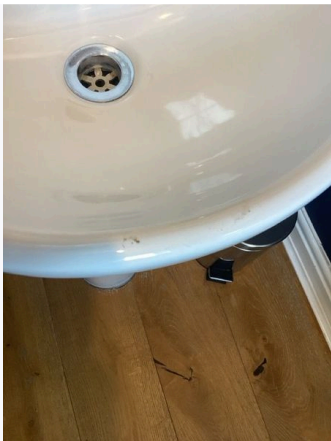
Ref #10.7

| 10. TOILET (CONT.) | | | |
|---|---|---|---|
| 10.7 | Sink | White ceramic pedestal sink with two separate chrome taps for hot and cold, circular overflow, and a metallic drain cover. | Minor marks and some staining on the rim, generally intact with no visible cracks or major damage, taps and waste appear functional. |

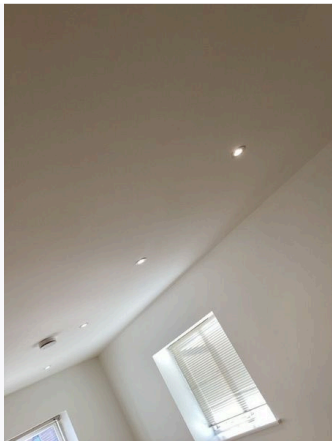
Ref #11.2

| Ref | Name | Description | Condition |
|---|---|---|---|
| 11.2 | Ceiling | Smooth white plaster ceiling with recessed spotlights and ceiling-mounted smoke detector. | No visible marks cracks or stains ceiling and fittings appear intact. |

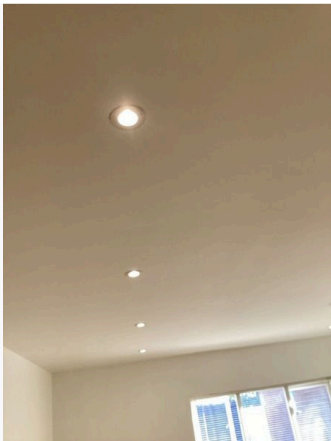
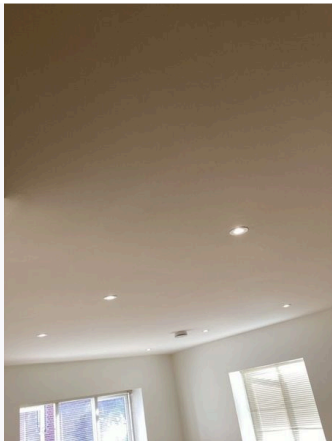
Ref #11.3

| Ref | Name | Description | Condition |
|---|---|---|---|
| 11.3 | Lighting | Ceiling-mounted recessed spotlights with white trim arranged in a linear pattern. | All lights appear to be functioning with no visible damage or wear to the fittings. |

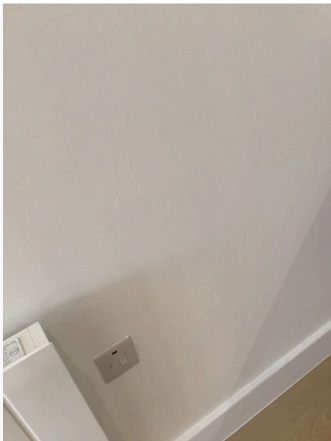
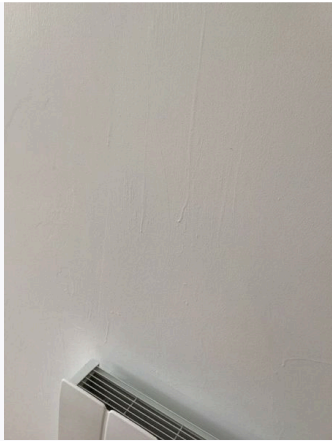
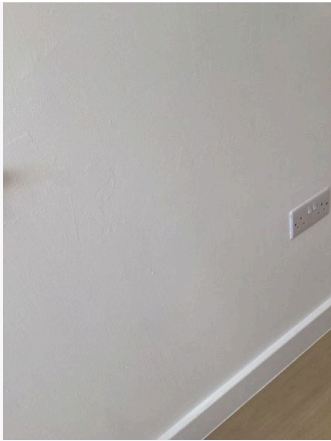
Ref #11.4

| Ref | Name | Description | Condition |
|---|---|---|---|
| 11.4 | Walls | Painted plastered walls in an off-white shade with multiple plug sockets and skirting board present. | Walls show minor surface imperfections and unevenness, overall intact with no visible cracks or severe damage. |

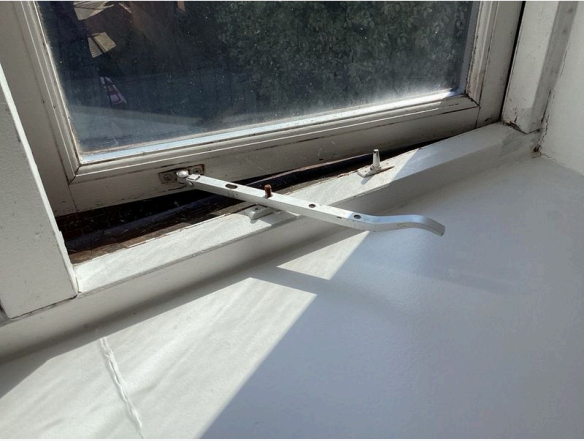
Ref #11.5

| Ref | Name | Description | Condition |
|---|---|---|---|
| 11.5 | Window | Three-panel casement window with white painted wooden frames, clear glass panes and fitted with a metal restrictor and Venetian blind, set within a deep white reveal. | Paint chipped and areas of exposed wood visible on lower frames, rust present on restrictor arm, general wear and slight signs of moisture damage on sill edges. |

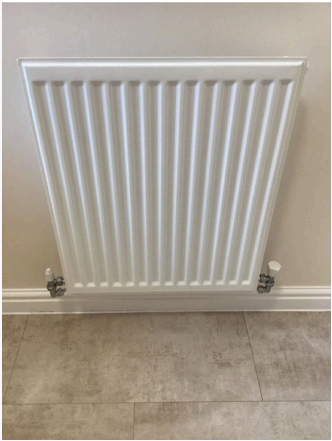
Ref #11.7

| Ref | Name | Description | Condition |
|---|---|---|---|
| 11.7 | Heating | White metal panel radiator with vertical ridges and two control valves located at the bottom corners. | No visible damage or signs of wear, paintwork intact and fittings appear secure. |

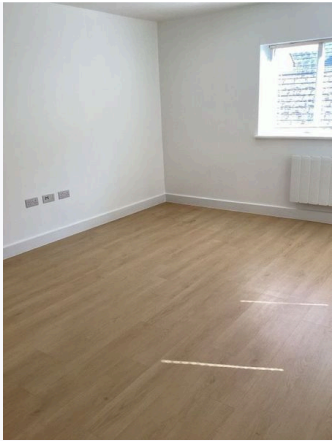
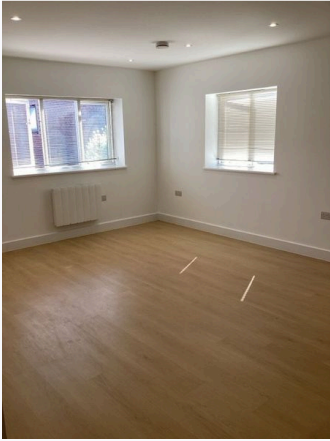
Ref #11.8

| Ref | Name | Description | Condition |
|---|---|---|---|
| 11.8 | Flooring | Light oak effect laminate flooring throughout the lounge. | No visible signs of wear, damage or staining. |

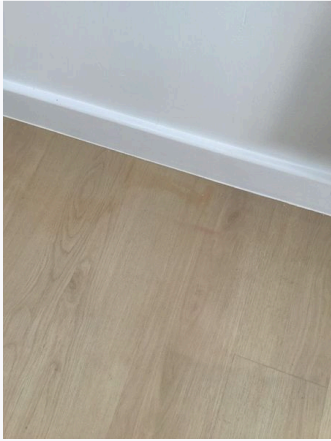
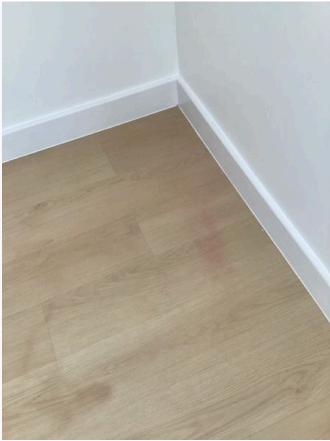
Ref #11.9

| Ref | Name | Description | Condition |
|---|---|---|---|
| 11.9 | Woodwork | White painted timber skirting boards running along the base of the walls. | Skirting boards are generally intact with no visible chips or cracks and surface paint appears undamaged. |

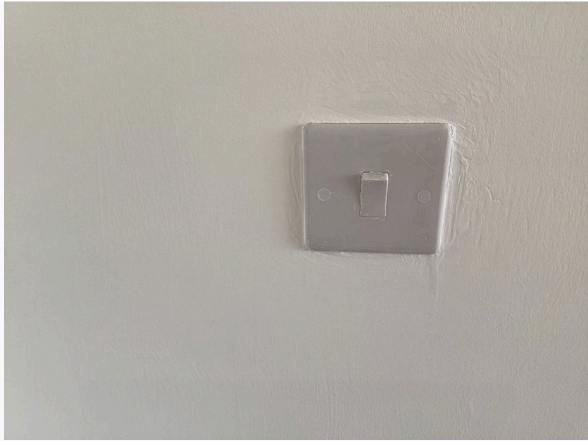
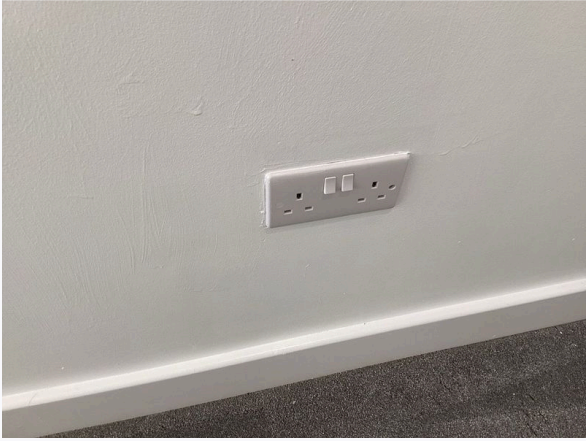
Ref #11.10

| Ref | Name | Description | Condition |
|---|---|---|---|
| 11.10 | Sockets/switches | White plastic fittings including single light switch, multiple double power sockets, and a media outlet, all flush-mounted against the wall. | All sockets and switches are intact with minor scuffs and surrounding paint unevenness but no visible cracks or significant damage. |

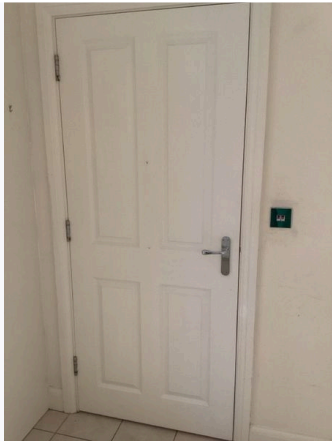
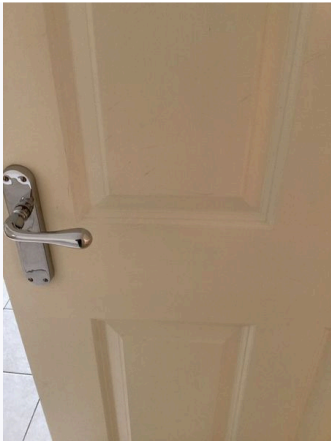
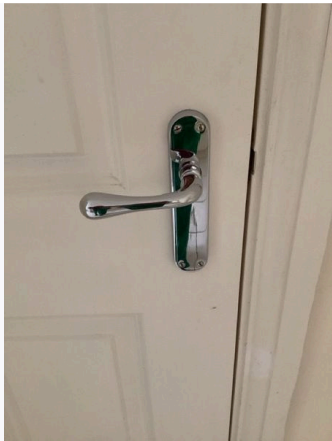
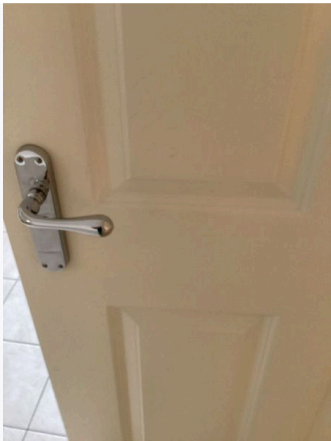
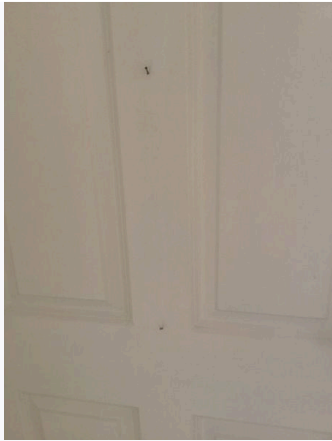
Ref #12.1

| Ref | Name | Description | Condition |
|---|---|---|---|
| 12.1 | Door | White four-panel wooden door with a silver lever handle and visible hinges. | Minor scuffs and marks visible on the surface<br>small screw holes above centre panel handle and hardware intact little visible wear on fittings. |

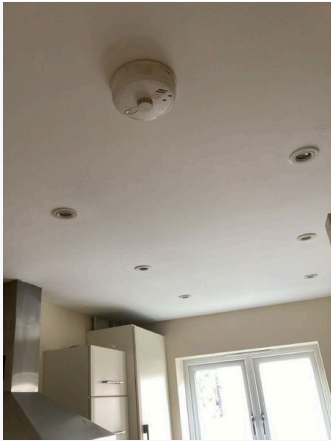
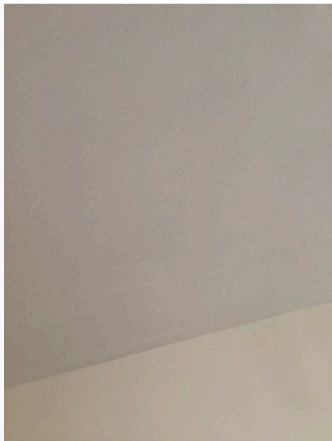
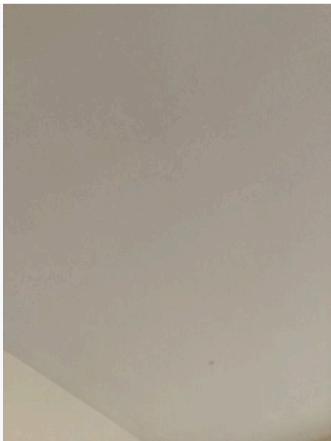
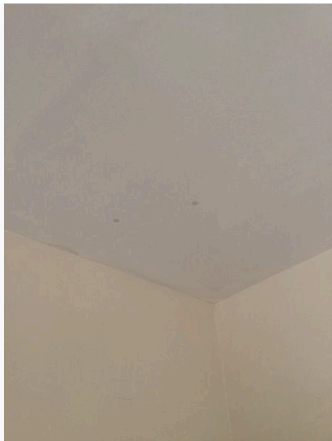
Ref #12.2

| Ref | Name | Description | Condition |
|---|---|---|---|
| 12.2 | Ceiling | White painted plasterboard ceiling with recessed spotlights and a smoke detector fitted. | Ceiling shows minor marks and faint discolouration in places with no visible cracks or significant damage observed. |

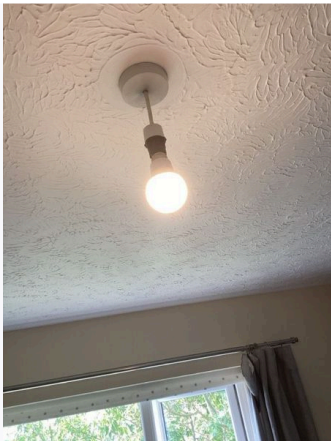
Ref #12.3

| Ref | Name | Description | Condition |
|---|---|---|---|
| 12.3 | Lighting | Ceiling-mounted pendant light with white plastic fitting and exposed bulb. | Light is operational with no visible damage or wear to fitting or bulb. |

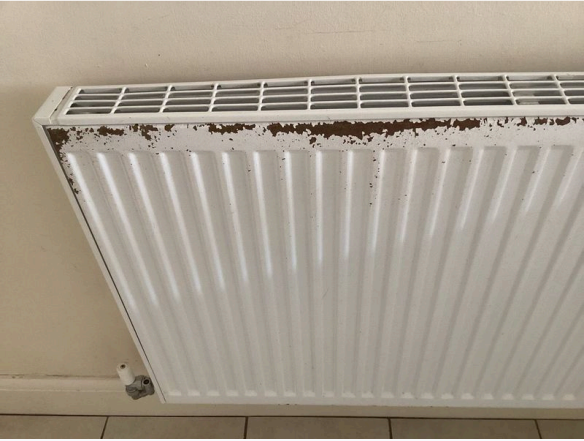
Ref #12.6

| Ref | Name | Description | Condition |
|---|---|---|---|
| 12.6 | Heating | White metal panel radiator with vertical ridges and thermostatic valve located on tiled floor against a painted wall. | Paint peeling and corrosion visible along the top edge, minor marks and surface rust present, thermostatic valve intact. |

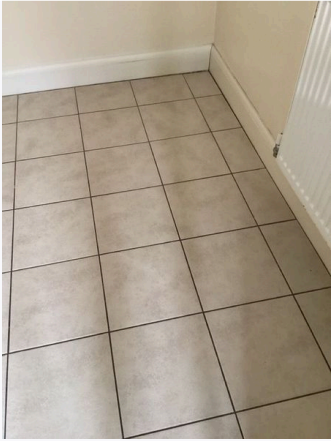
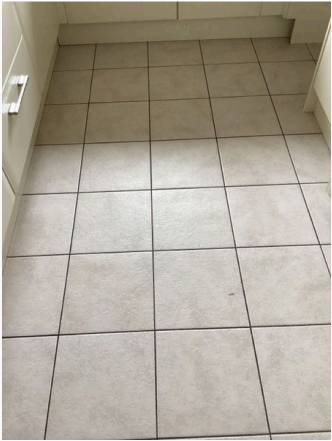
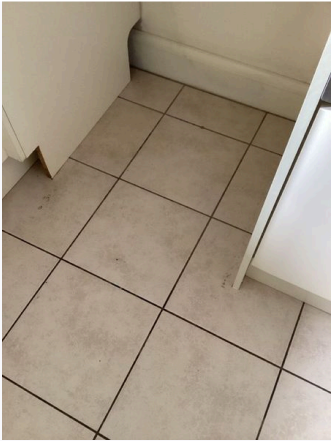
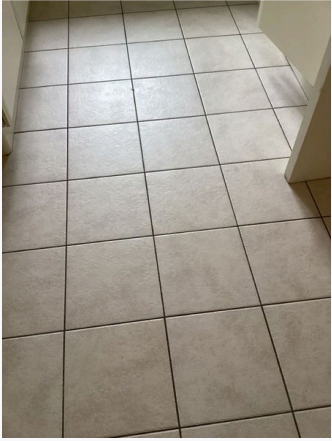
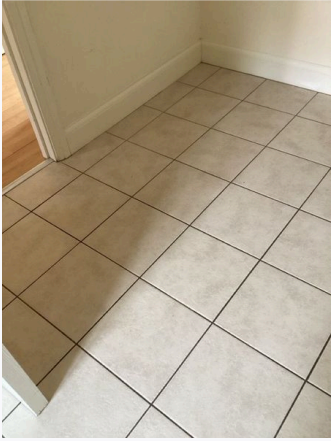
Ref #12.7

| Ref | Name | Description | Condition |
|---|---|---|---|
| 12.7 | Flooring | Ceramic floor tiles in a light beige colour with a subtle mottled pattern and dark grout lines. | Floor tiles appear in good condition with minor surface marks and slight discolouration to some grout lines. |

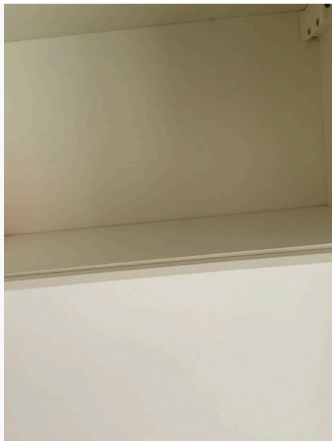
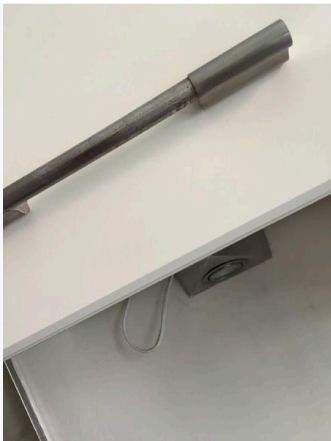
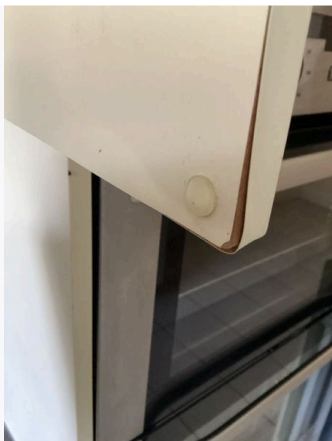
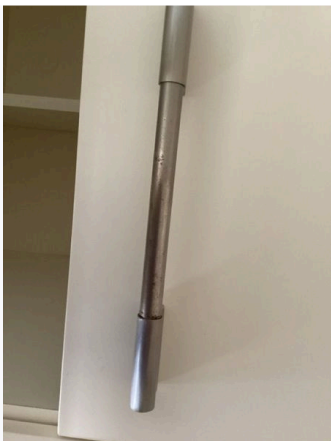
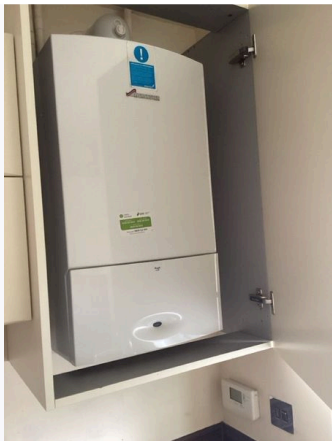
Ref #12.8

| Ref | Name | Description | Condition |
|---|---|---|---|
| 12.8 | Kitchen Units | Kitchen units are finished in a cream-coloured laminate with simple flat-fronted doors, fitted with long brushed steel bar handles, and feature various cupboards and drawers for storage. | Units show signs of wear including visible chipped edges, minor surface marks, and some worn handles but are largely intact and functional. |

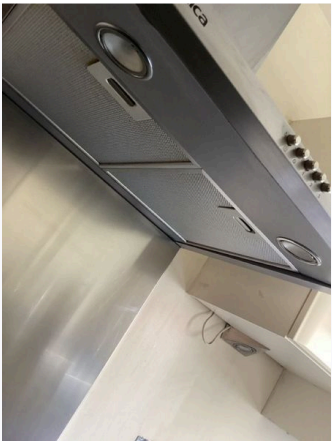
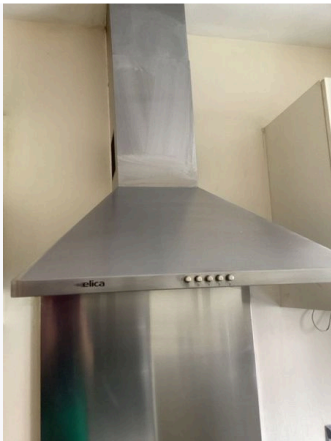
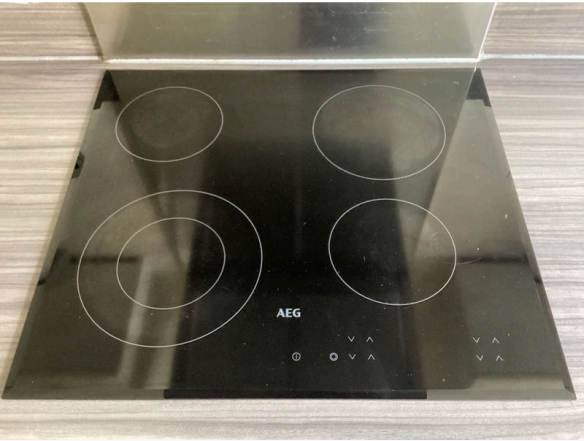
Ref #12.9

| Ref | Name | Description | Condition |
|---|---|---|---|
| 12.9 | Extractor Hood | Stainless steel extractor hood with control buttons located at the front, mesh filter panels and integrated lighting. | Extractor hood appears clean with minor surface marks and no visible damage to the body or controls. |

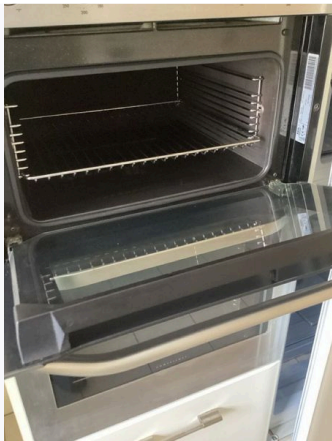
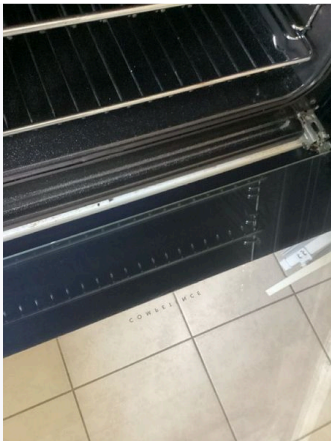
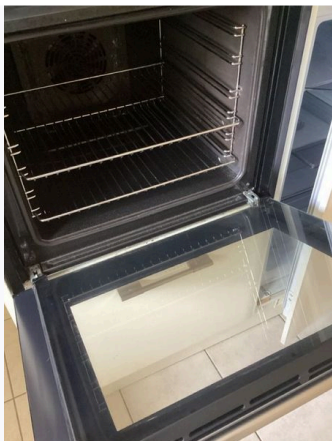
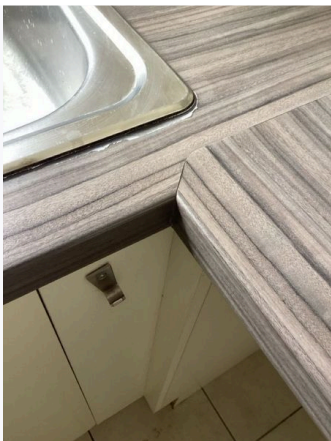
Ref #12.11

| 12. KITCHEN (CONT.) | | | |
|---|---|---|---|
| 12.11 | Oven | Stainless steel AEG built-in double oven with glass doors and multiple wire racks. | Oven appears clean with no visible signs of damage or significant wear. |

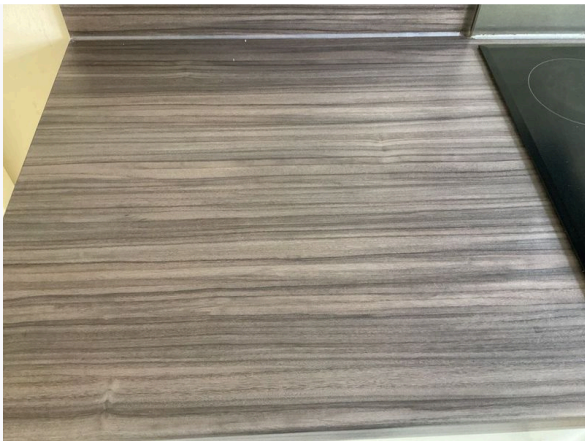
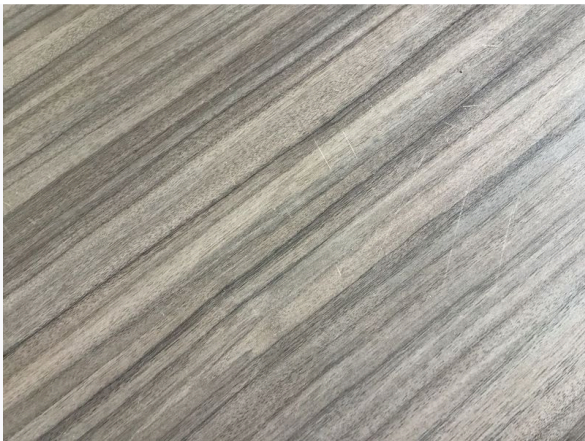
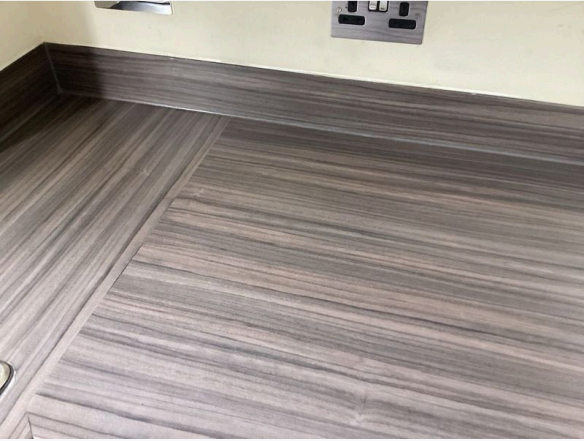
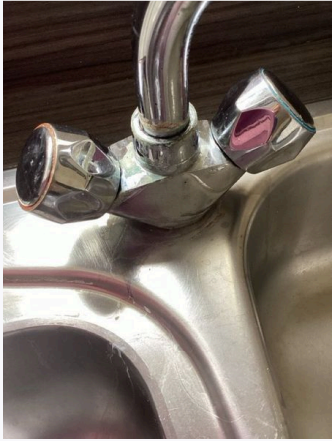
Ref #12.12

| 12. KITCHEN (CONT.) | | | |
|---|---|---|---|
| 12.12 | Worktop(s) | Laminate worktops with a wood-effect grey and brown striated finish, integrated upstands, and inset with a stainless steel sink and electric hob. | Worktops show light surface scratches and minor signs of use, but no major damage or chips visible. |

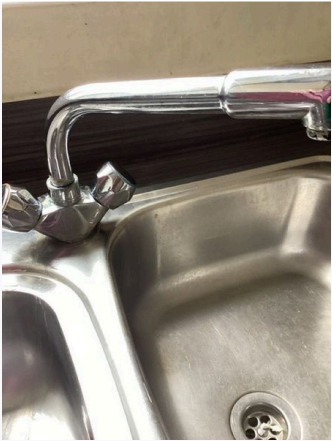
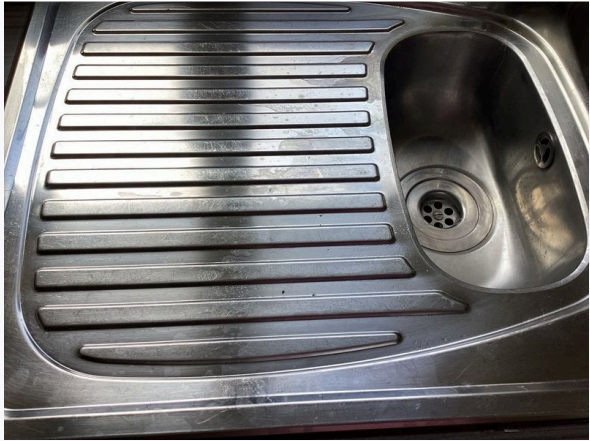
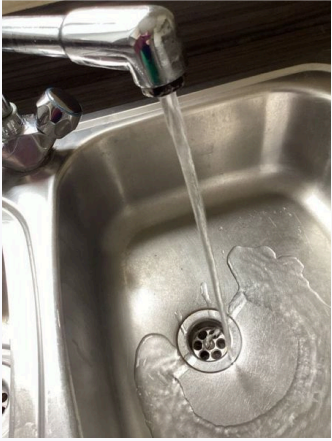
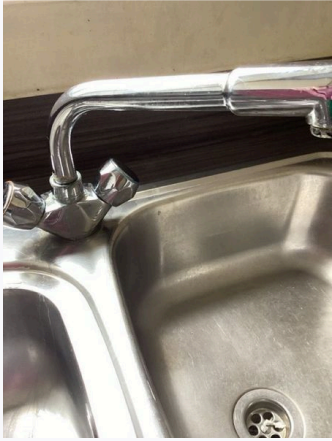
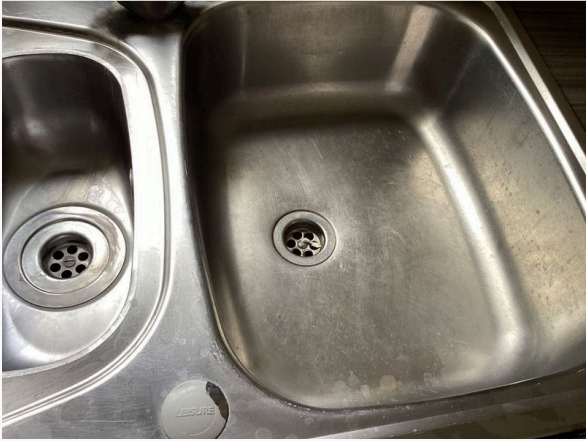
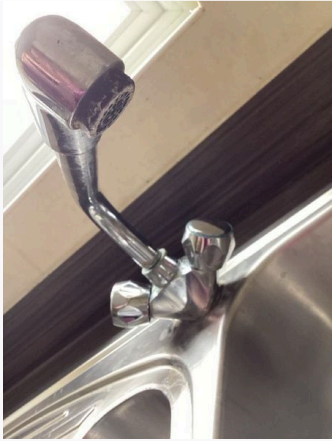
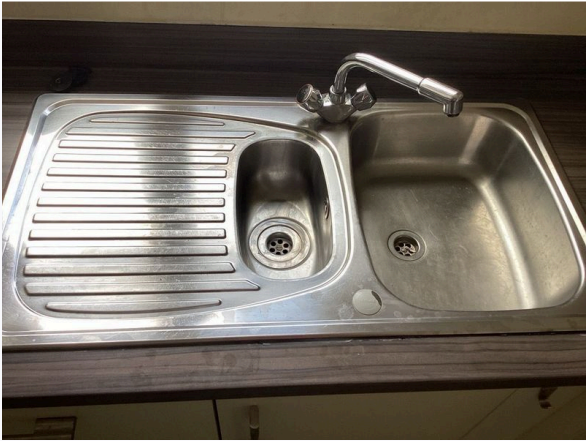
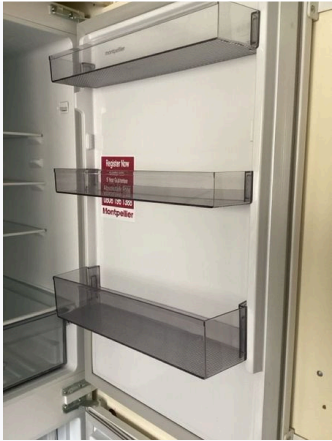
Ref #12.13

| 12. KITCHEN (CONT.) | | | |
|---|---|---|---|
| 12.13 | Sink | Stainless steel double bowl sink with drainer and chrome dual-handle mixer tap. | Light surface scratches and some staining visible on sink and drainer, minor limescale around tap and base, otherwise appears functional. |

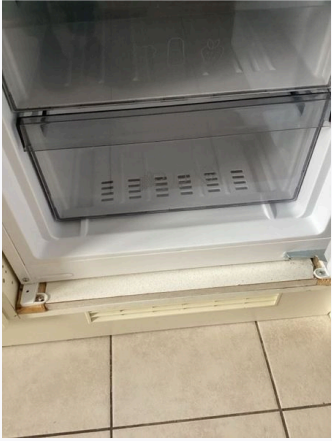
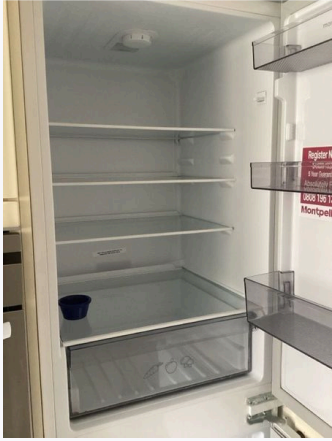
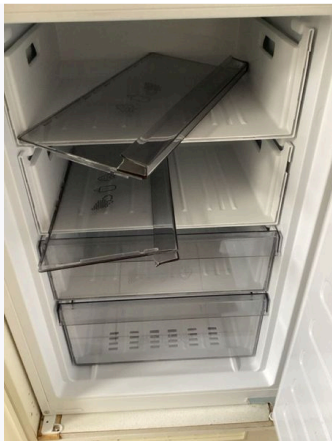
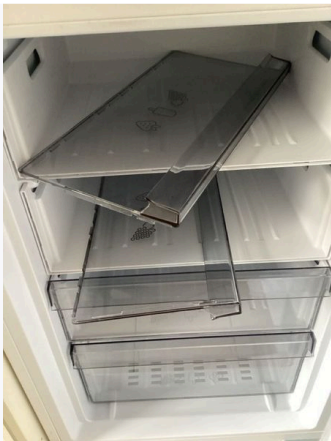
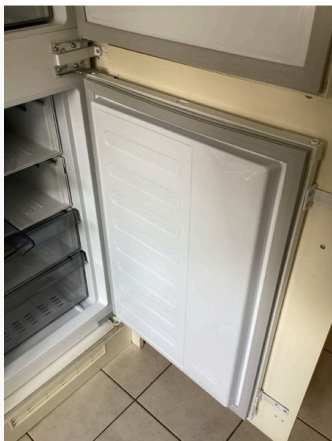
Ref #12.14

| 12. KITCHEN (CONT.) | | | |
|---|---|---|---|
| 12.14 | Fridge / Freezer | Integrated Montpellier fridge freezer with white interior, transparent plastic shelves and drawers, multiple door compartments, and separate fridge and freezer sections. | Interior appears clean with all main components present, some freezer drawer fronts are detached but visible, minor rust to lower hinge area. |

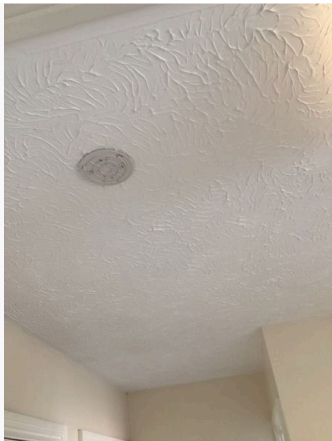
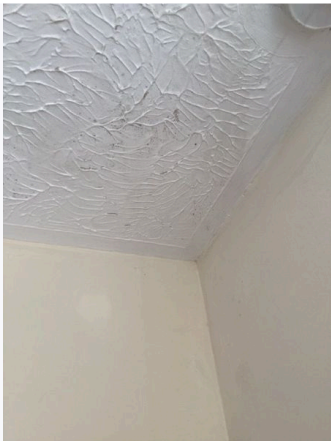
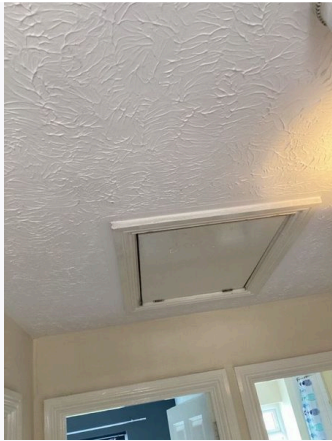
Ref #13.1

| Ref | Name | Description | Condition |
|---|---|---|---|
| 13.1 | Ceiling | White textured plaster ceiling with a fitted smoke alarm and a loft hatch. | Ceiling appears generally intact with some minor surface marks and signs of wear near the corners. |

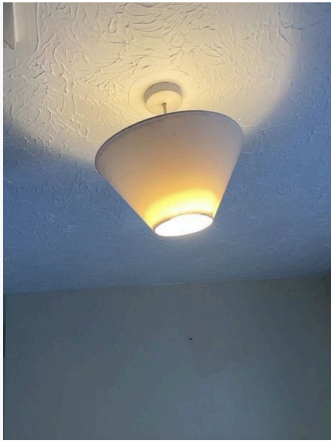
Ref #13.2

| Ref | Name | Description | Condition |
|---|---|---|---|
| 13.2 | Lighting | Ceiling-mounted cone-shaped light fitting with opaque white shade and central bulb. | Light fitting is functional with some minor surface marks on the shade and no visible damage. |

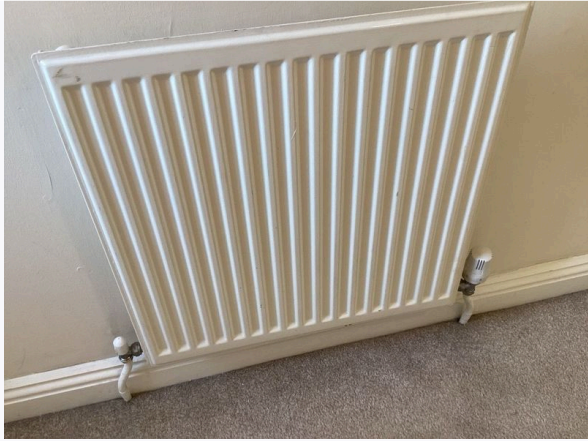
Ref #13.4

| Ref | Name | Description | Condition |
|---|---|---|---|
| 13.4 | Heating | White metal panel radiator with vertical ridges and thermostatic valve installed on the wall above carpeted floor. | Radiator shows minor scuffs and marks to the top edge but otherwise appears intact with no visible damage. |

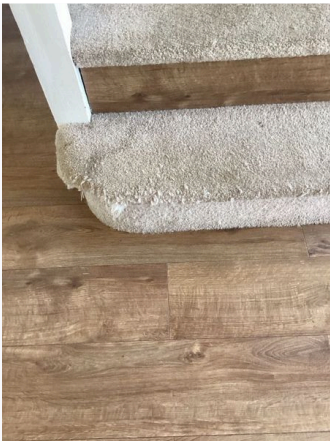
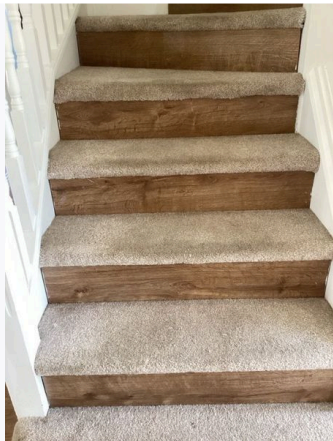
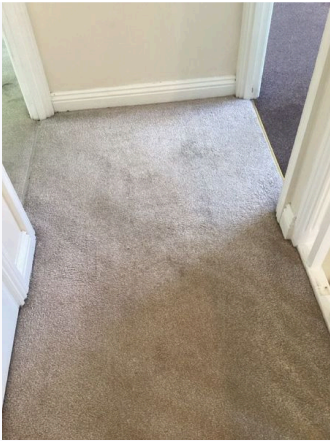
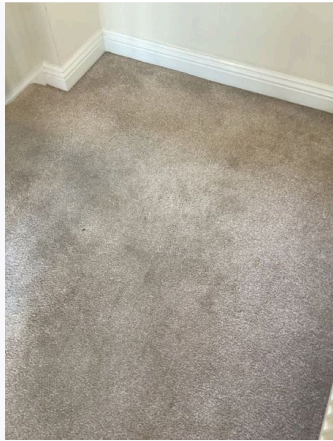
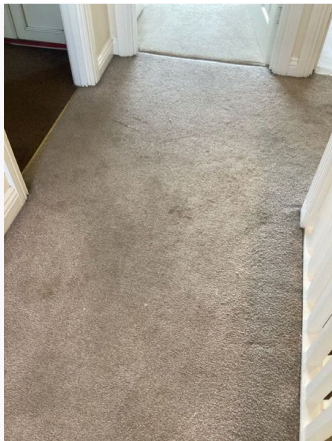
Ref #13.5

| Ref | Name | Description | Condition |
|---|---|---|---|
| 13.5 | Flooring | Beige carpet fitted on the stairs and landing with wood effect covering on stair risers and adjacent flooring. | Carpet on stairs is frayed at the edges and shows visible wear, landing carpet is flattened and displays multiple stains and areas of discolouration. |

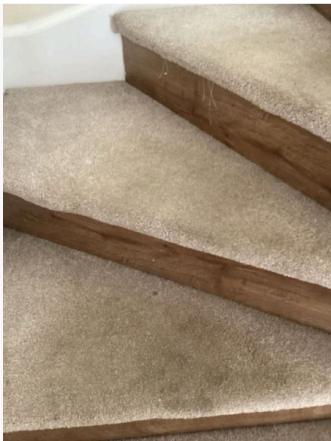
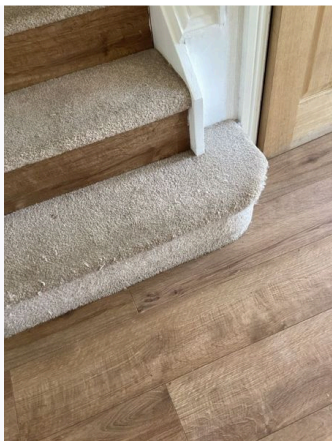
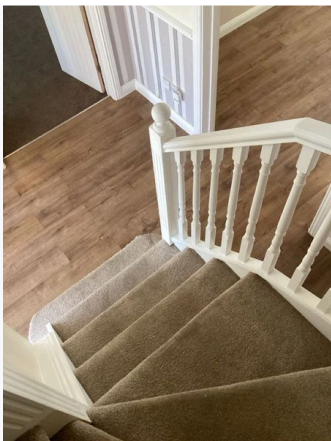
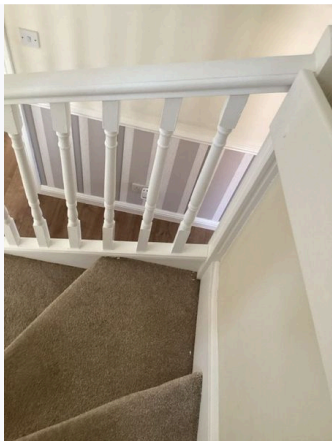
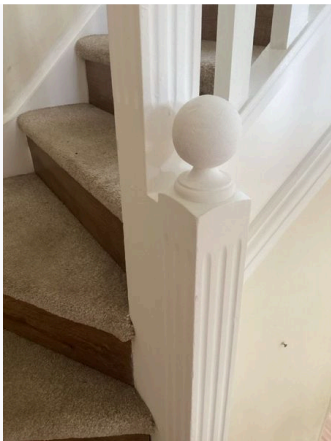
Ref #13.6

| Ref | Name | Description | Condition |
|---|---|---|---|
| 13.6 | Staircase | Staircase with beige carpeted treads and wooden risers featuring white painted spindles and handrails. | The carpet shows minor marks and wear, with some fraying at the edges; balustrade and handrails are intact and painted. |

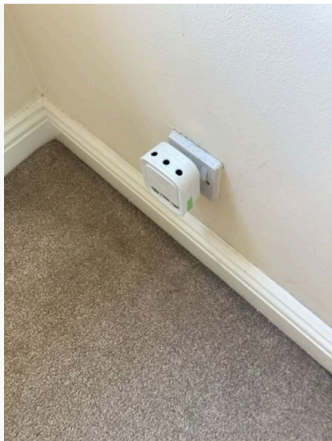
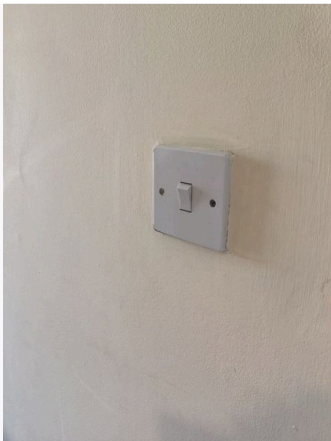
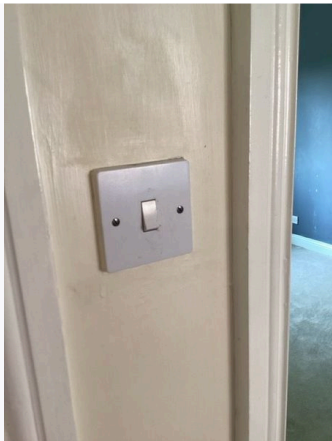
Ref #13.7

| Ref | Name | Description | Condition |
|---|---|---|---|
| 13.7 | Sockets/switches | White plastic electrical socket and two white plastic light switches with single toggles fitted to the wall in the stairs and landing area | Socket and switches appear clean with some minor discolouration and paint marks around the edges no visible cracks or damage |

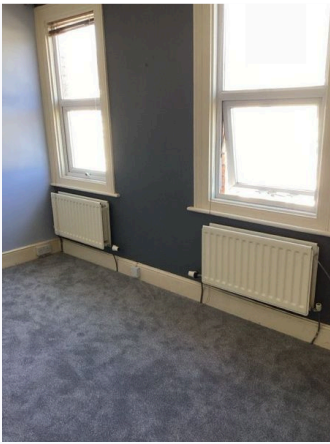
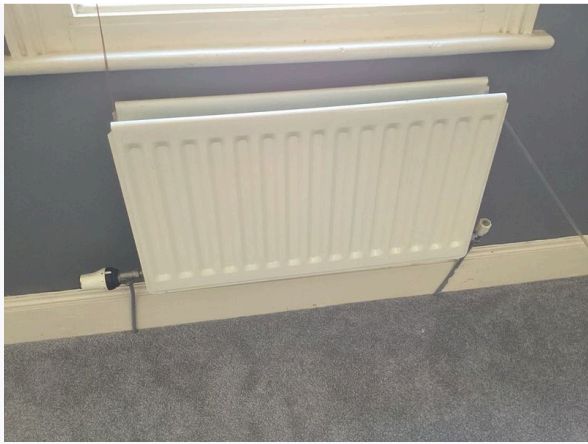
Ref #14.6

| 14. BEDROOM 1 (CONT.) | | | |
|---|---|---|---|
| 14.6 | Heating | Two white metal panel radiators with horizontal alignment and manual control valves located under the windows | Both radiators appear in good condition with no visible damage or signs of rust |

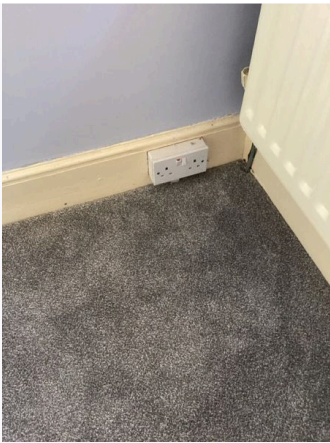
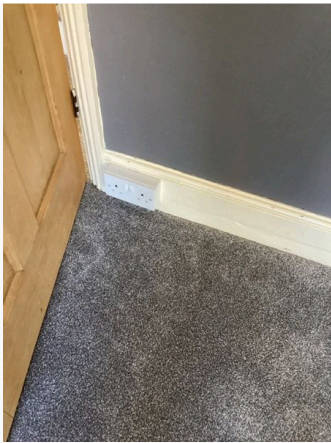
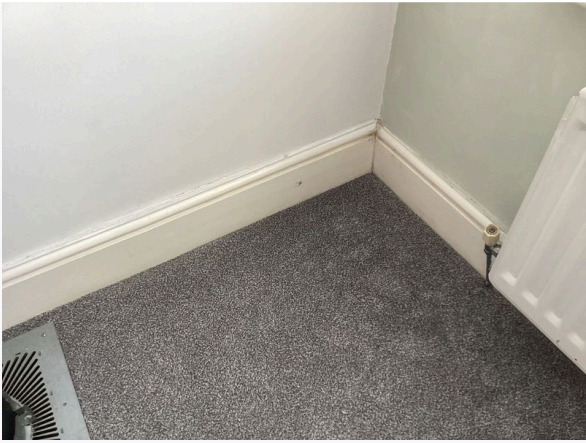
Ref #14.7

| 14. BEDROOM 1 (CONT.) | | | |
|---|---|---|---|
| 14.7 | Flooring | Grey carpet flooring with a short pile and consistent colour throughout the room. | Flooring appears clean with no visible stains, tears, or significant wear. |

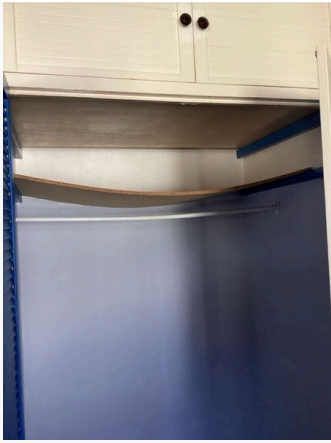
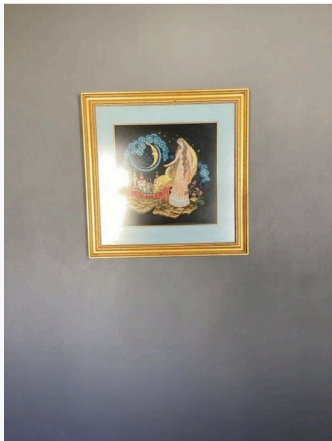
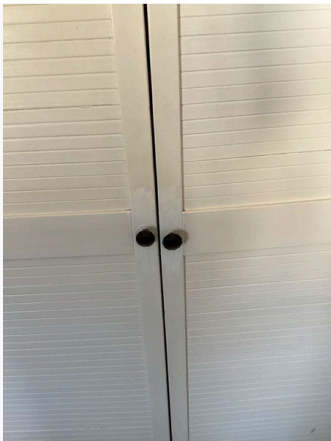
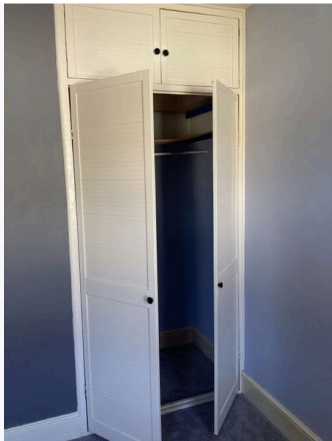
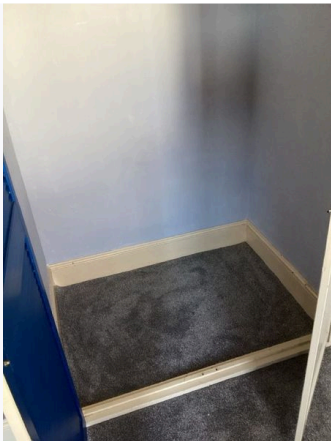
Ref #14.8

| 14. BEDROOM 1 (CONT.) | | | |
|---|---|---|---|
| 14.8 | Additional Items / Information | Built-in white painted wardrobe with panelled doors and black handles, upper storage cupboard, single hanging rail, lower carpeted area, and framed decorative wall art with gold and blue border. | Wardrobe shelf is sagging in the middle, doors and handles show minor scuffing, hanging rail appears intact, carpeted floor is clean, wall art and frame are free of visible damage. |
