# Inventory & Schedule of Condition

Test house  
Any Town  
Wiltshire

**July**  
**1st 2026**

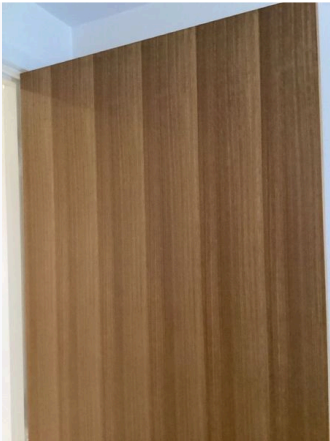
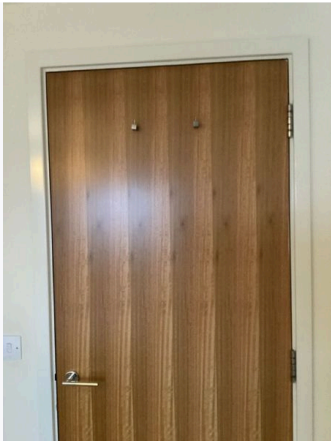
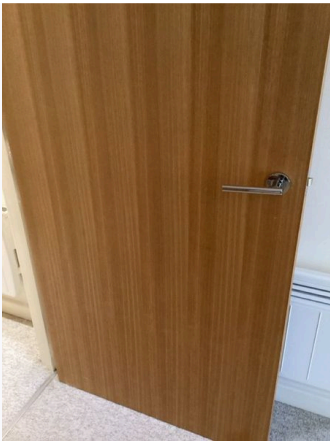
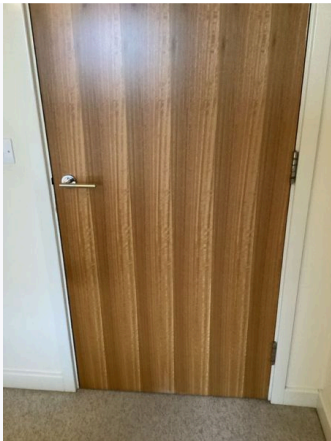
Ref #15.1

| Ref | Name | Description | Condition |
|---|---|---|---|
| 15.1 | Door | Timber-veneered door with vertical grain pattern featuring a metallic handle and two wall hooks on the upper panel. | The door is in good condition with no visible scratches, dents or chips and fixtures appear intact. |

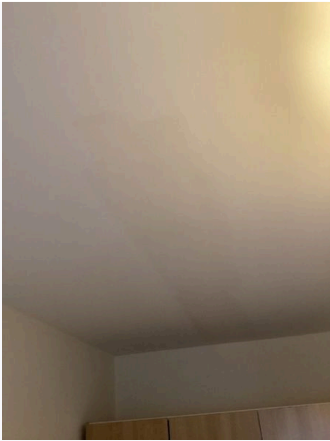
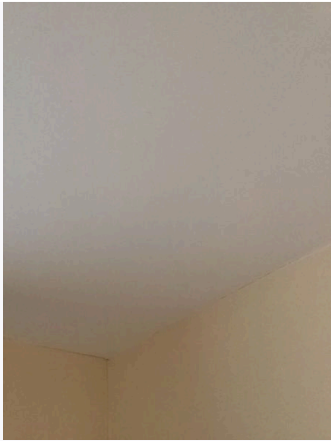
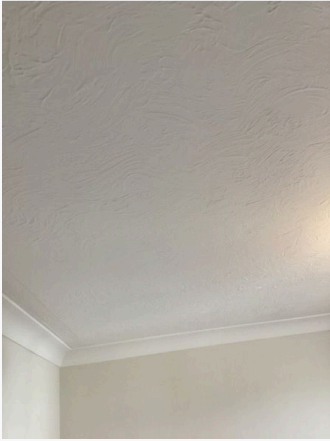
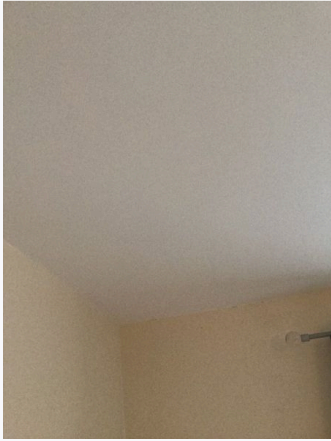
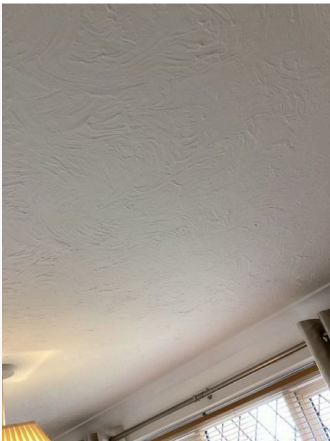
Ref #15.2

| Ref | Name | Description | Condition |
|---|---|---|---|
| 15.2 | Ceiling | Smooth white painted ceiling with no visible decorative features. | Ceiling shows some discolouration and patchiness, with no visible cracks or structural damage. |

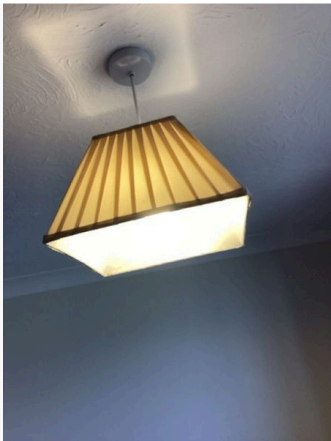
Ref #15.3

| 15. BEDROOM 2 (CONT.) | | | |
|---|---|---|---|
| 15.3 | Lighting | Square cream pleated fabric lampshade suspended from ceiling pendant with visible compact fluorescent bulb inside. | Shade appears slightly misshapen with minor creasing visible on fabric otherwise no obvious signs of damage or wear. |

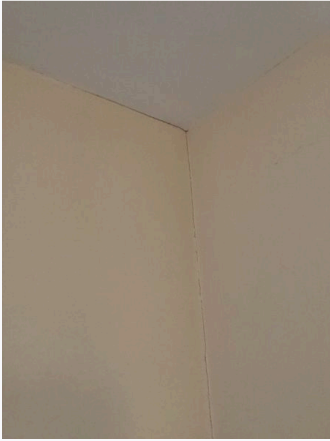
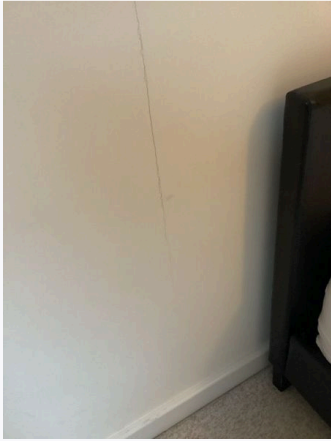
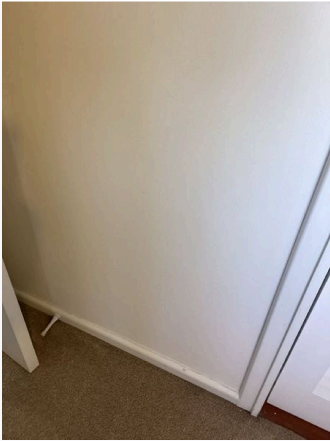
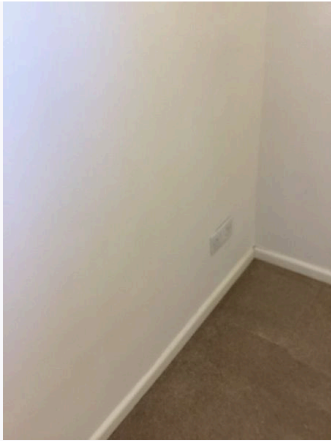
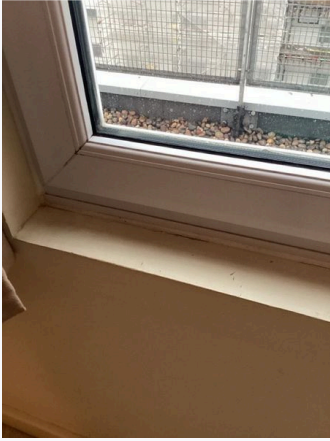
Ref #15.4

| 15. BEDROOM 2 (CONT.) | | | |
|---|---|---|---|
| 15.4 | Walls | Painted plaster walls in light neutral colours with white skirting boards. | Walls display visible cracks in several areas and minor scuffs at skirting level but are otherwise intact. |

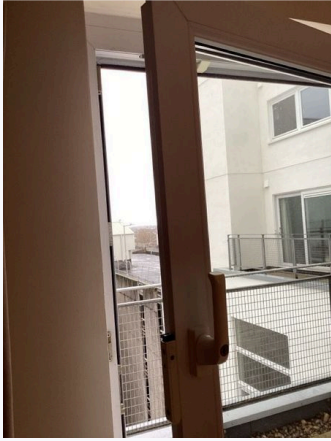
Ref #15.5

| 15. BEDROOM 2 (CONT.) | | | |
|---|---|---|---|
| 15.5 | Window | White uPVC double glazed tilt and turn window with integrated handle and trickle vent. | Window frame and glass in good condition with no visible cracks; window sill has visible cracks and some scuff marks. |

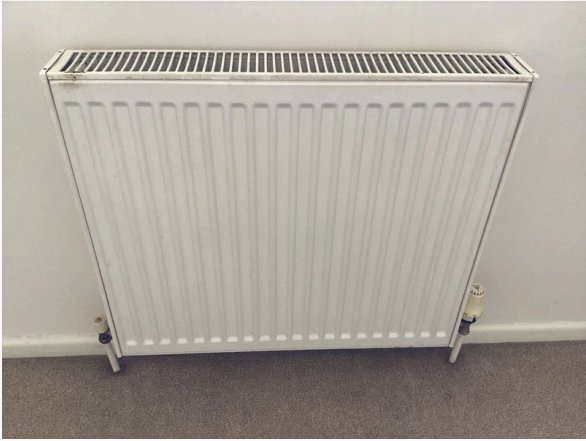
Ref #15.6

| 15. BEDROOM 2 (CONT.) | | | |
|---|---|---|---|
| 15.6 | Heating | White metal panel radiator with vertical ridges and a thermostatic valve mounted on the wall in Bedroom 2. | Minor discolouration and marks on the top edge, otherwise no visible damage or leaks. |

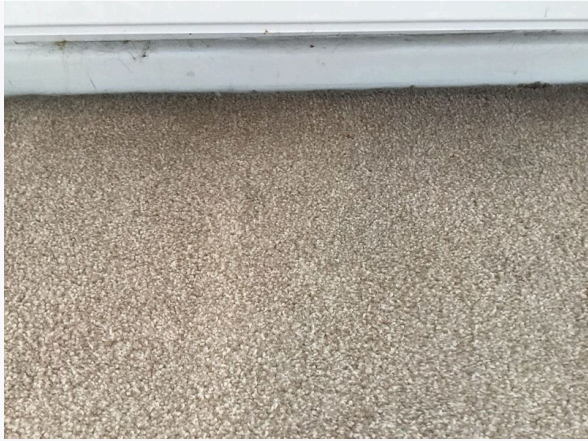
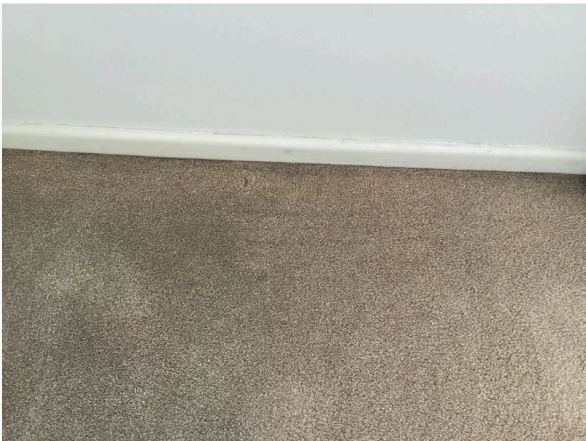
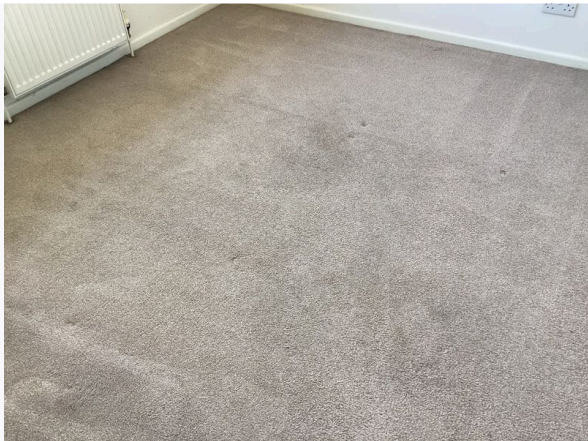
Ref #15.7

| 15. BEDROOM 2 (CONT.) | | | |
|---|---|---|---|
| 15.7 | Flooring | Light beige carpet flooring wall-to-wall fitted in bedroom 2. | The carpet shows several areas of discolouration and visible marks with indentations likely from furniture presents generally worn appearance. |

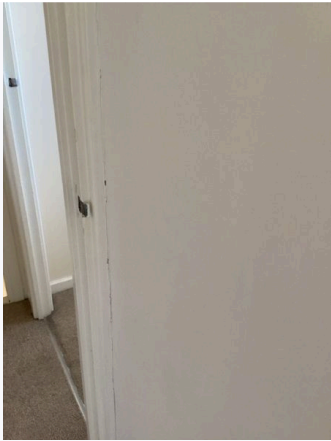
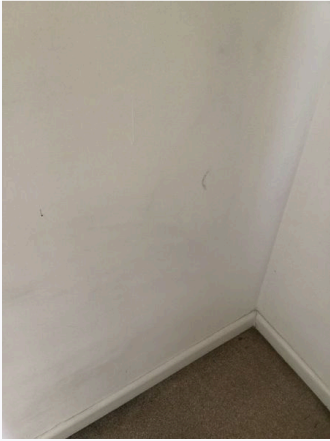
Ref #15.9

| 15. BEDROOM 2 (CONT.) | | | |
|---|---|---|---|
| 15.9 | Woodwork | White painted timber skirting boards and architrave around the doorway | Skirting boards show minor scuff marks and some discolouration; architrave has chipped paint and minor wear visible |

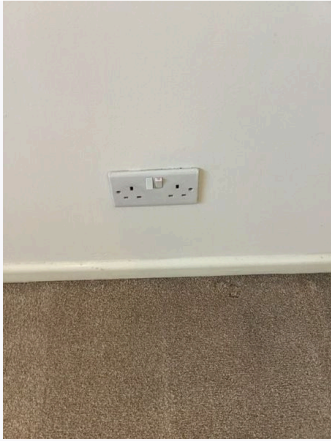
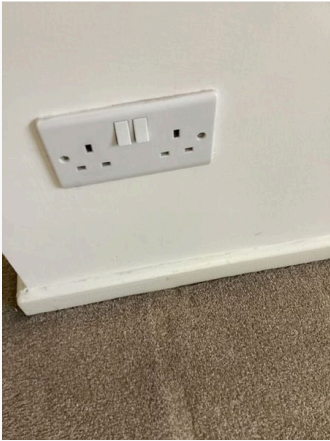
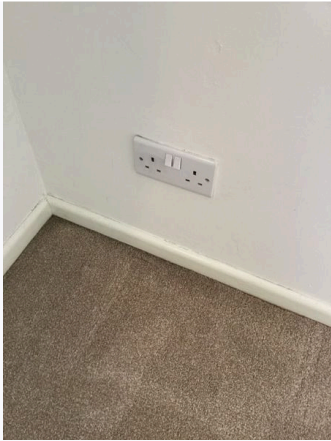
| 15. BEDROOM 2 (CONT.) | | | |
|---|--|---|--|
| Ref #15.10 | | Ref #15.10 | |

| 15. BEDROOM 2 (CONT.) | | | |
|---|---|---|---|
| 15.10 | Sockets/switches | White plastic double socket outlets with integrated switches fitted to painted walls at skirting level in Bedroom 2. | Sockets and switches appear intact with no visible damage or significant wear on the faceplates or switches. |

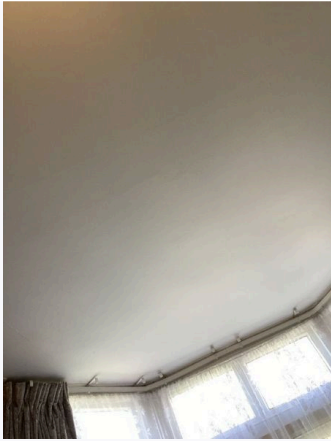
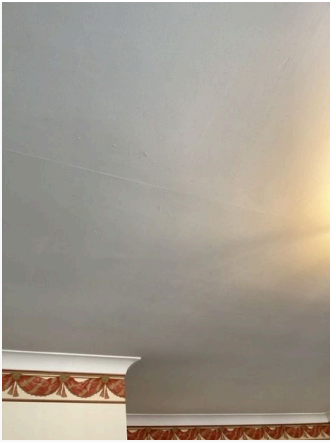
| 16. BEDROOM 3 | | | |
|---|---|---|---|
| 16.2 | Ceiling | Smooth white painted plaster ceiling with plain coving around the perimeter. | Ceiling has visible minor cracks and some small imperfections but no significant damage. |

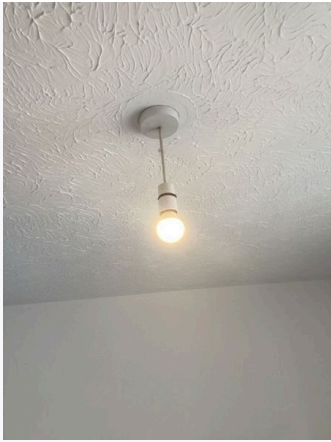
| 16. BEDROOM 3 | | | |
|---|---|---|---|
| 16.3 | Lighting | Single ceiling-mounted pendant light featuring a white fitting and an exposed bulb. | Lighting is operational with no visible damage or wear to the fitting or bulb. |

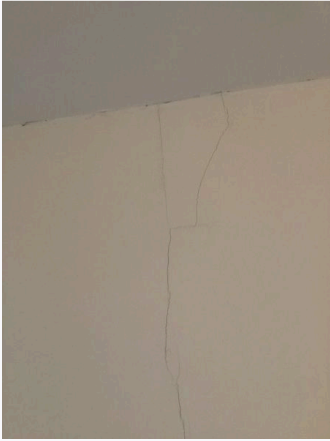
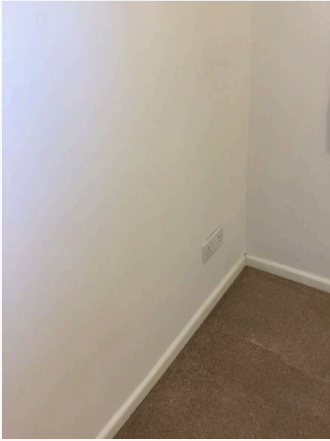
Ref #16.4

| 16. BEDROOM 3 | | | |
|---|---|---|---|
| 16.4 | Walls | Painted plasterboard walls in a light cream colour with a standard skirting board and electrical socket present. | There are visible vertical cracks in the plaster to one area while the remaining wall sections appear intact with no significant marks or damage. |

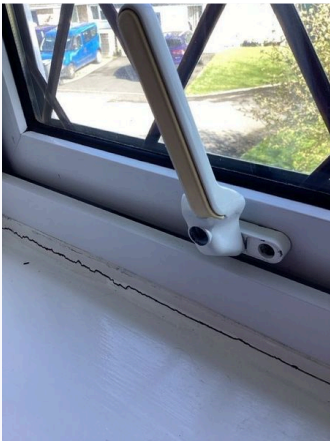
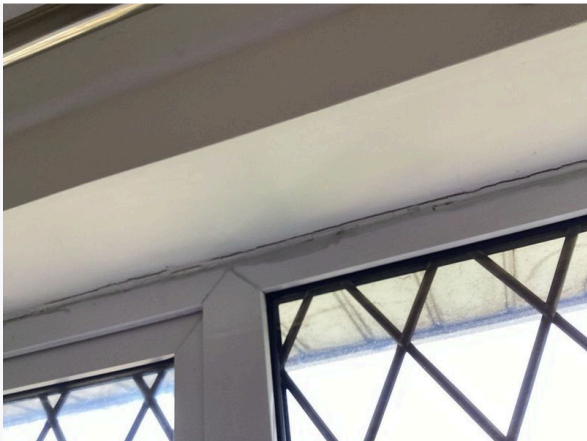
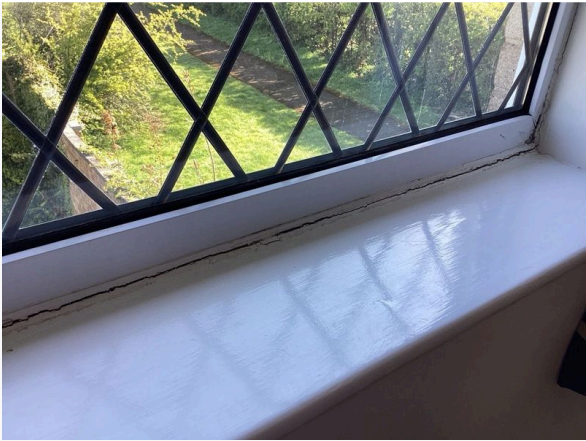
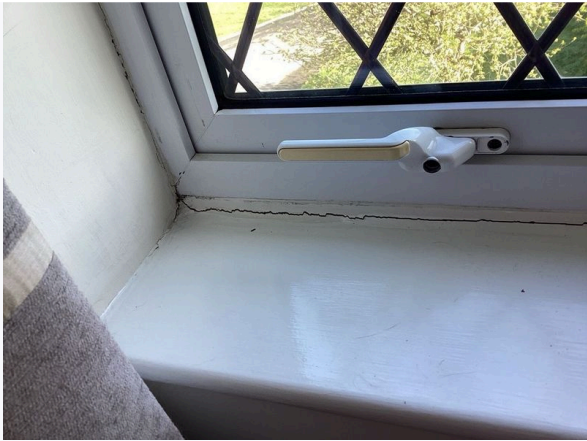
Ref #16.5

| 16. BEDROOM 3 | | | |
|---|---|---|---|
| 16.5 | Window | White uPVC window with double glazing, diamond leaded design, white window handles, and a security restrictor cable fitted. | Multiple cracks visible along window sill and reveals, some signs of paint deterioration, and minor dirt accumulation in window tracks. |

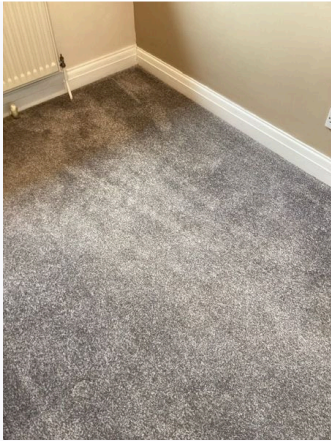
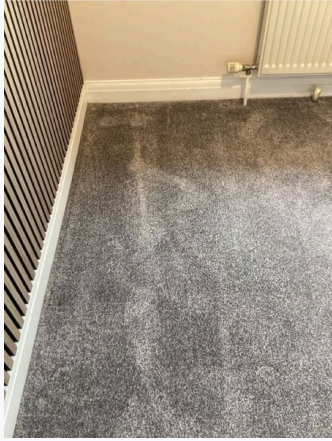
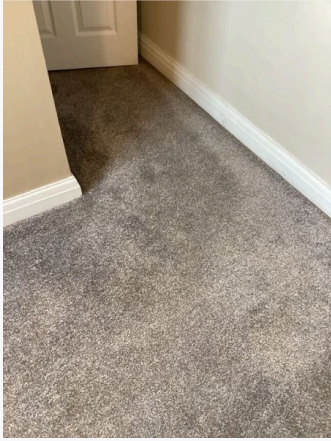
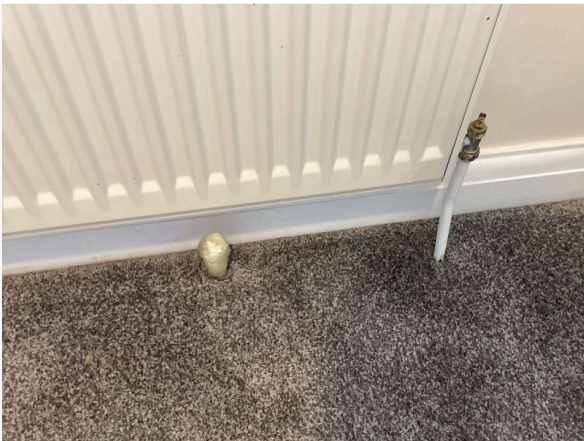
Ref #16.7

| 16. BEDROOM 3 (CONT.) | | | |
|---|---|---|---|
| 16.7 | Flooring | Grey carpet flooring fitted wall-to-wall with a short pile and uniform appearance. | Flooring appears clean with no visible stains or tears, minor pressure marks present from foot traffic and furniture. |

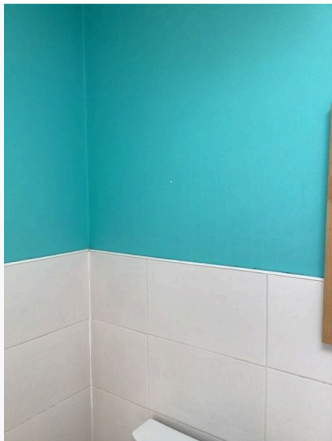
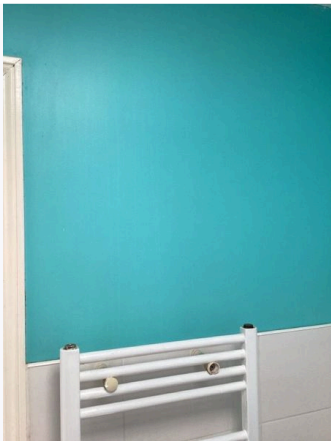
Ref #17.4

| Ref | Name | Description | Condition |
|---|---|---|---|
| 17.4 | Walls | Lower half finished with white ceramic tiles upper half painted turquoise smooth finish | Tiles and paintwork in good order with minor scuff marks on painted sections no significant damage or staining visible |

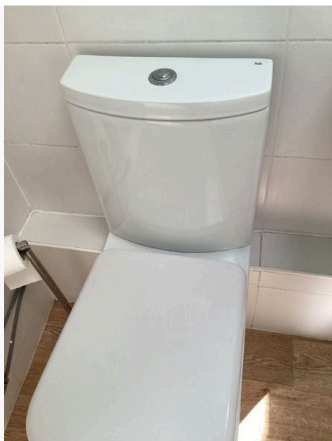
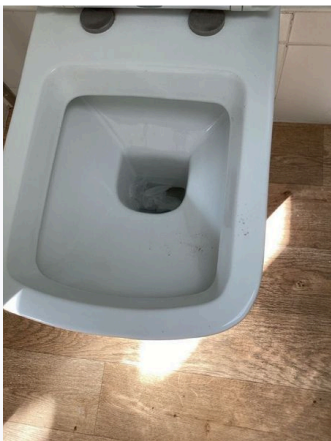
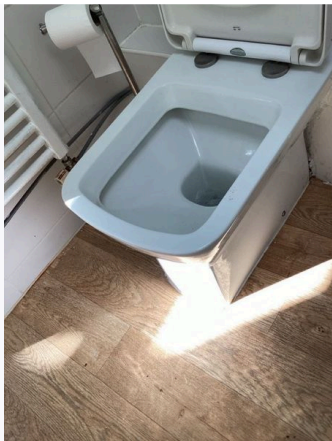
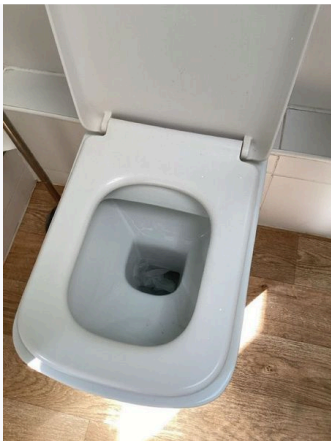
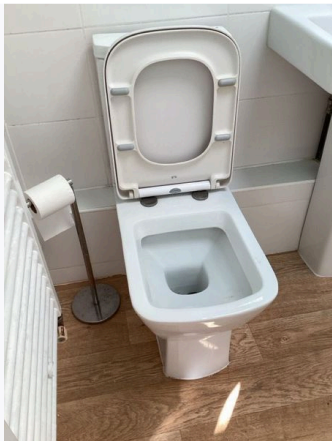
Ref #17.5

| Ref | Name | Description | Condition |
|---|---|---|---|
| 17.5 | Toilet | White ceramic close-coupled toilet with a dual flush button, rectangular seat and lid, and a modern design. | Toilet appears clean with no visible chips, cracks, or staining, fittings and seat intact, flush button present.<br><div>Needs Maintenance</div> |

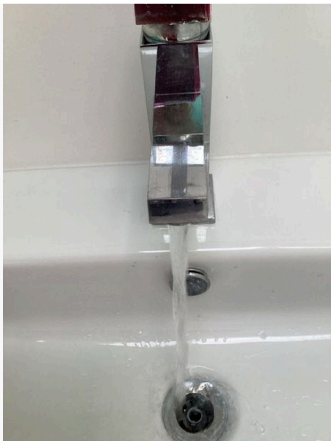
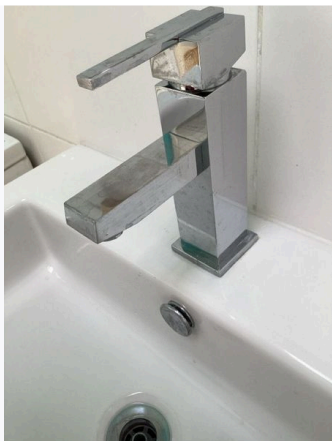
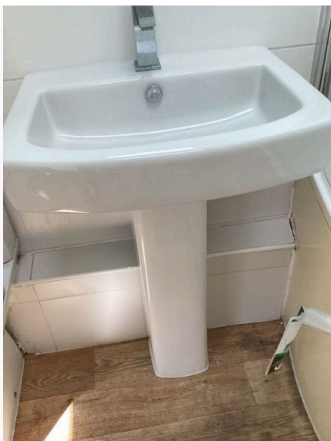
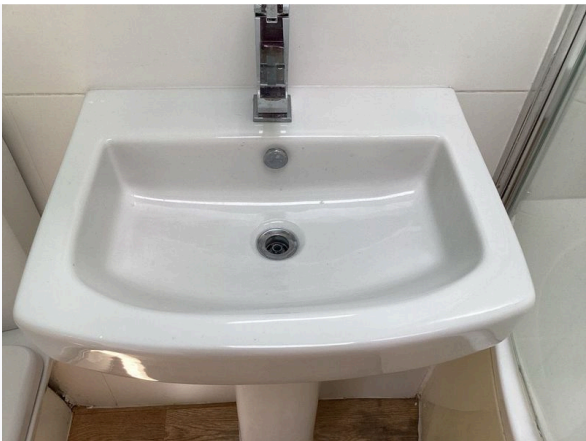
Ref #17.6

| 17. BATHROOM (CONT.) | | | |
|---|---|---|---|
| 17.6 | Basin | White ceramic pedestal basin with rectangular shape and chrome single lever mixer tap. | Basin is in good functional condition with some limescale and tarnishing visible on the tap. |

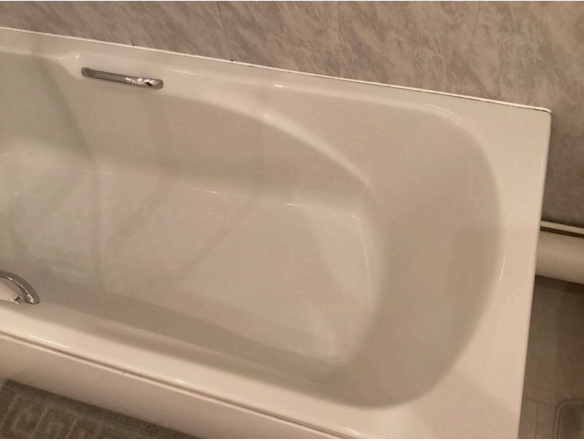
Ref #17.7

| 17. BATHROOM (CONT.) | | | |
|---|---|---|---|
| 17.7 | Bath / Bath Panel | Acrylic white bath with a curved pale cream-coloured bath panel and integrated chrome hand grips. | Bath panel has visible scuffing and a crack near the edge, sealant appears worn, bath surface itself appears clean with no obvious damage. |

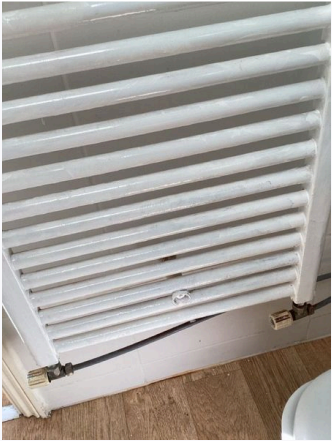
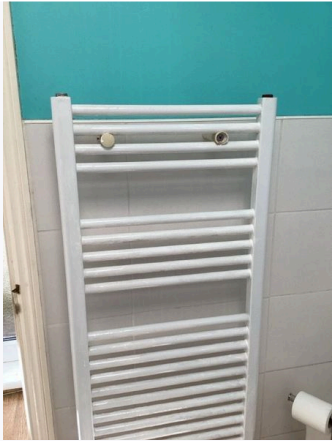
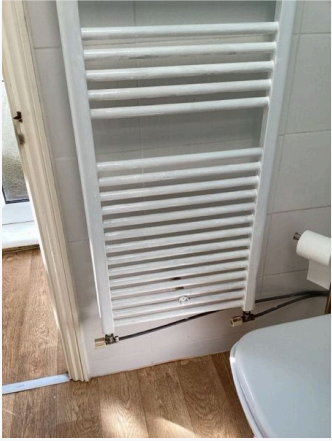
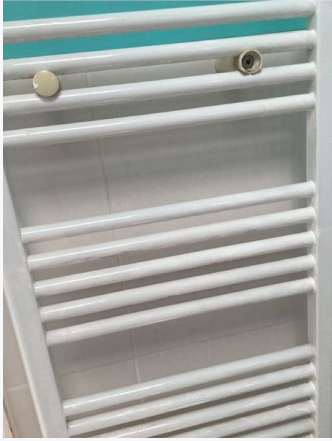
| 17. BATHROOM (CONT.) | | | |
|---|---|---|---|
| 17.8 | Heating | White wall-mounted heated towel rail with horizontal bars and manual valves, made of metal. | Areas of chipped paint, some rust and discolouration visible on lower bars and valve fittings. |

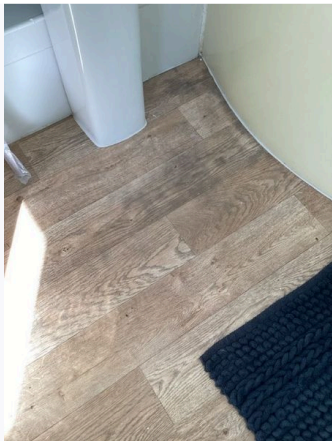
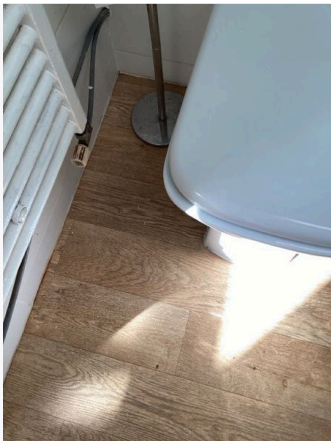
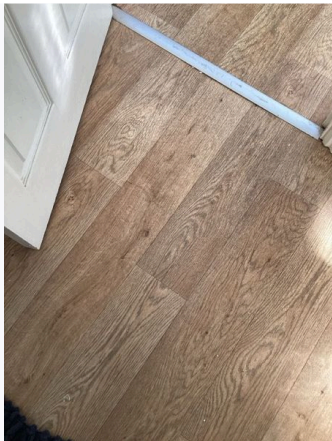
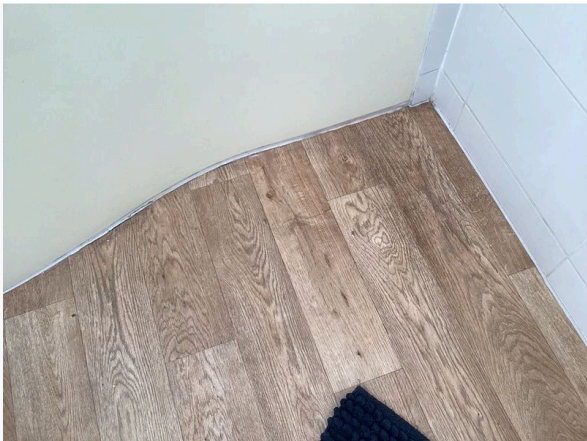
| 17. BATHROOM (CONT.) | | | |
|---|---|---|---|
| 17.9 | Flooring | Wood-effect vinyl flooring in a medium oak shade with a plank design. | Light marks and minor surface debris visible, no significant damage or lifting observed. |

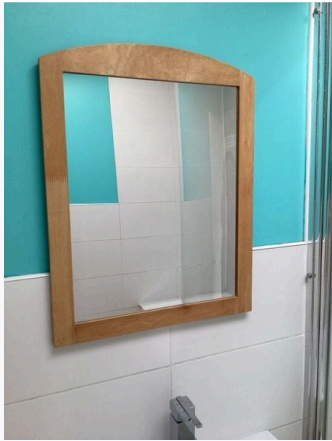
Ref #17.10

| 17. BATHROOM (CONT.) | | | |
|---|---|---|---|
| 17.10 | Accessories | Rectangular wall-mounted mirror with a light wood frame. | Mirror and frame appear clean with no visible damage or noticeable wear. |

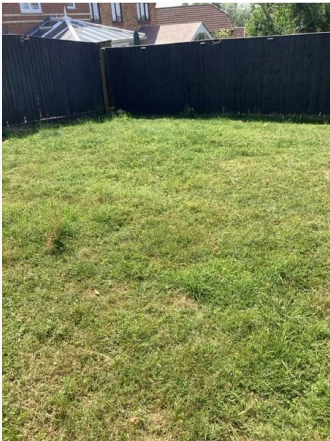
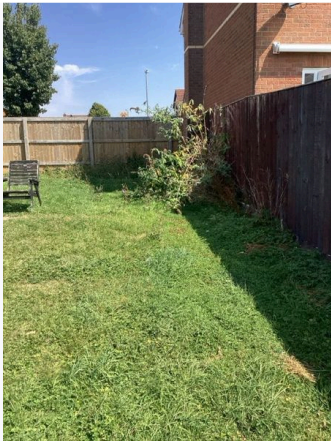
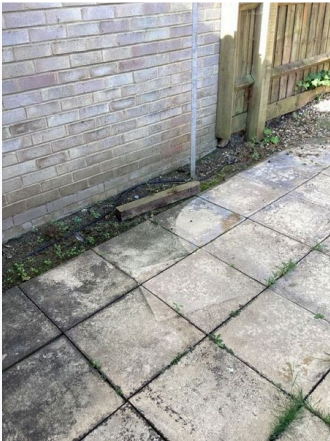
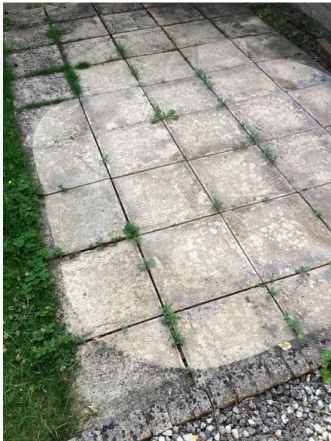
| Ref | Name | Description | Condition |
|---|---|---|---|
| 18.1 | Garden Description | Lawn area with green grass, some overgrown patches, mature border shrubbery, dark timber fencing, paved patio section adjacent to property | Grass showing uneven growth and some overgrown areas, shrubs appear untidy, fencing generally intact, paving slabs have visible staining and weeds growing between joints |

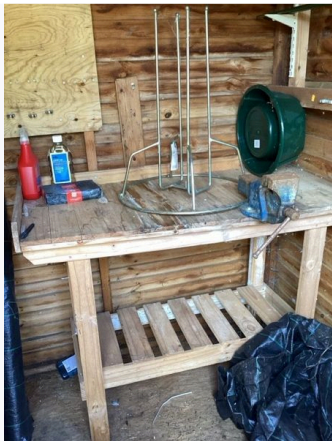
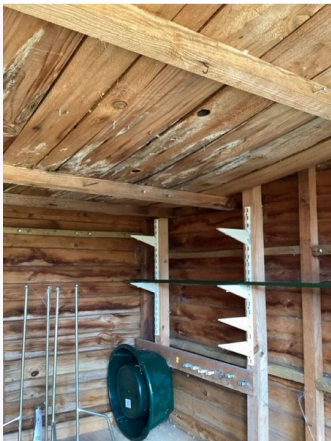
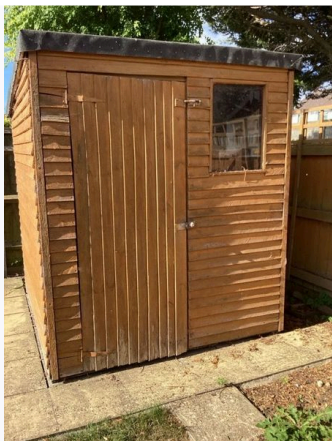
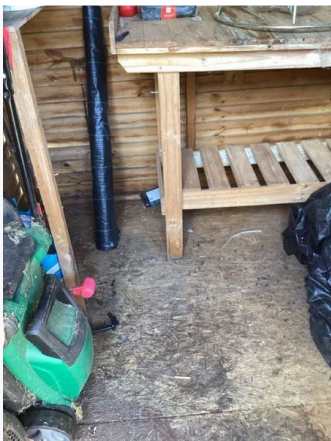
| 18. REAR GARDEN (CONT.) | | | |
|---|---|---|---|
| 18.2 | Shed(s) | Timber shed with a pitched felt roof, wooden panelled walls, single window, lockable door, fitted workbench, shelving and wooden plank floor. | General wear with marks and scuffing to internal surfaces, signs of damp and water staining on ceiling panels, some dirt and surface wear to floor, otherwise structurally intact. |
